Petrological Analysis of the Anglo-Saxon and Anglo-Norman Stonework of St Peter's, Wearmouth and St Paul's, Jarrow

John Senior
With Sarah Semple, Alex Turner and Sam Turner
McCord Centre Report 2014.2

April 2014

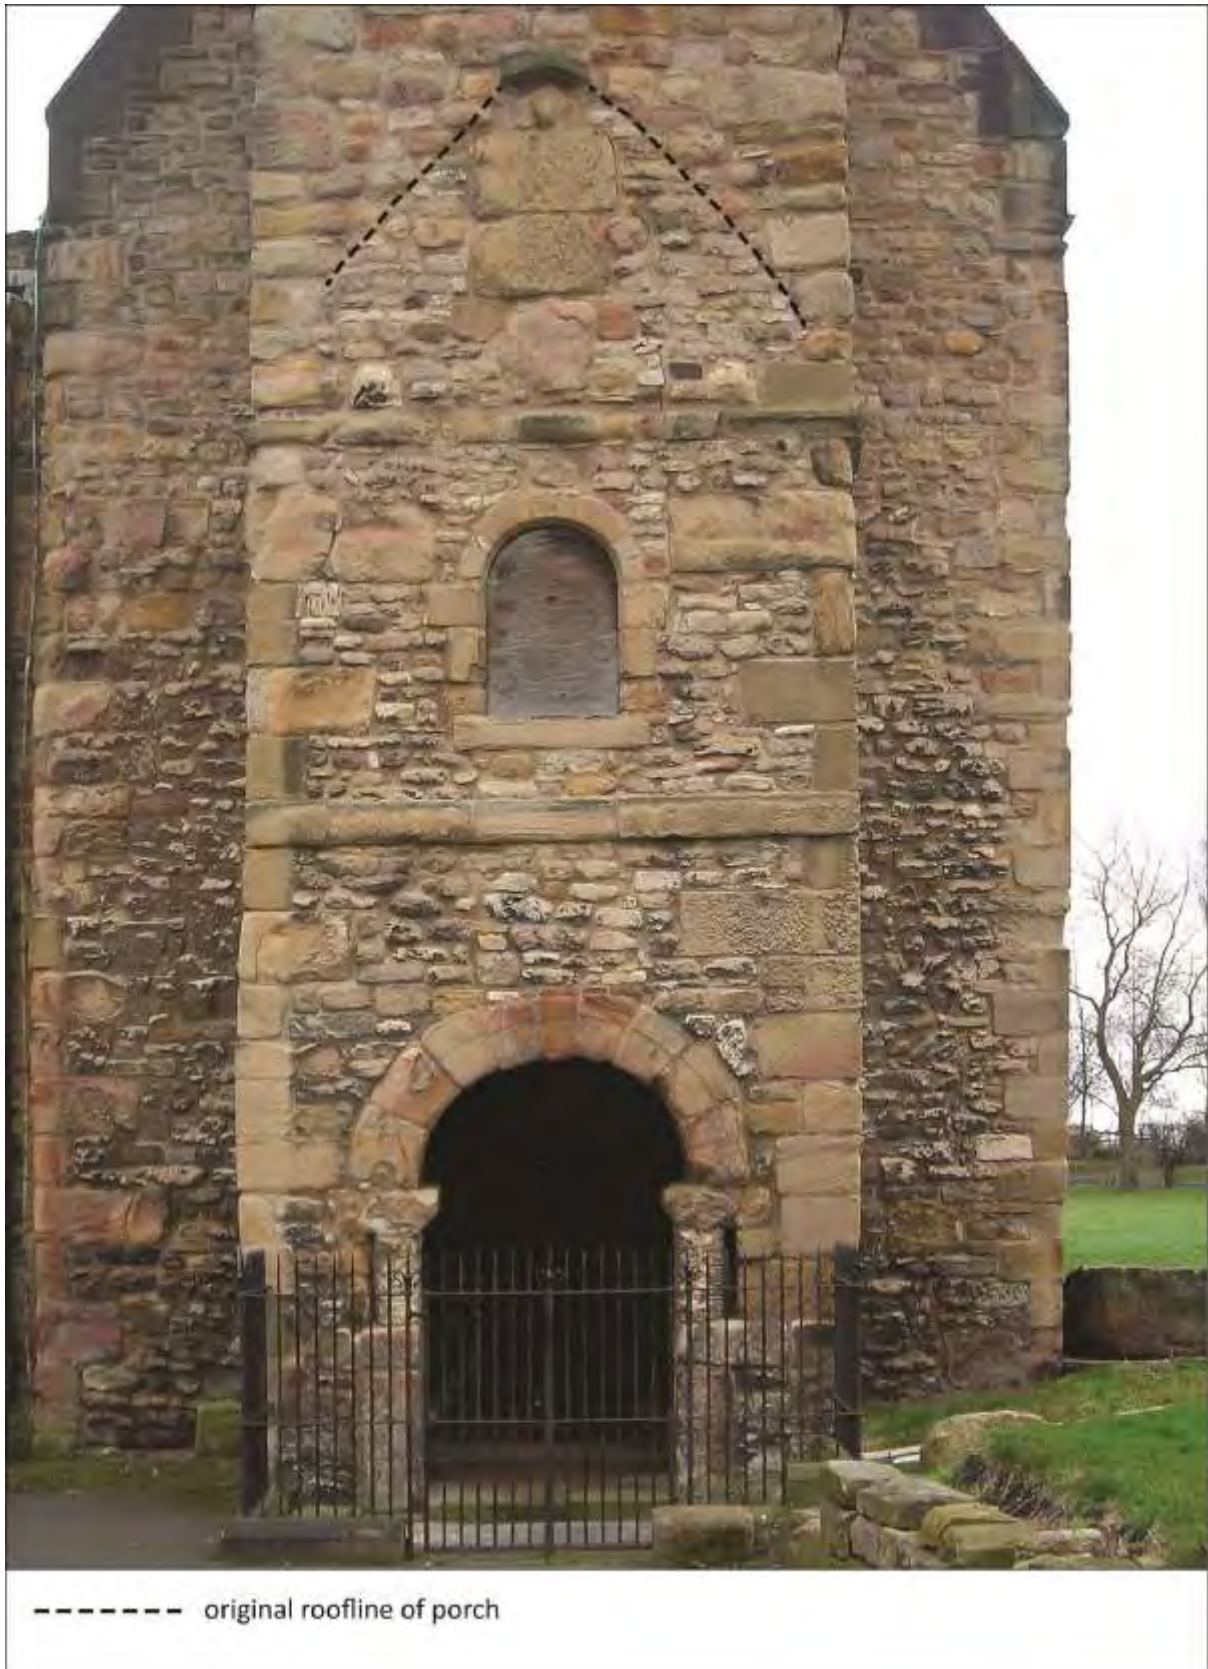
Figure 2: Western porch entrance, St. Peter's, Wearmouth. Showing original roof line.

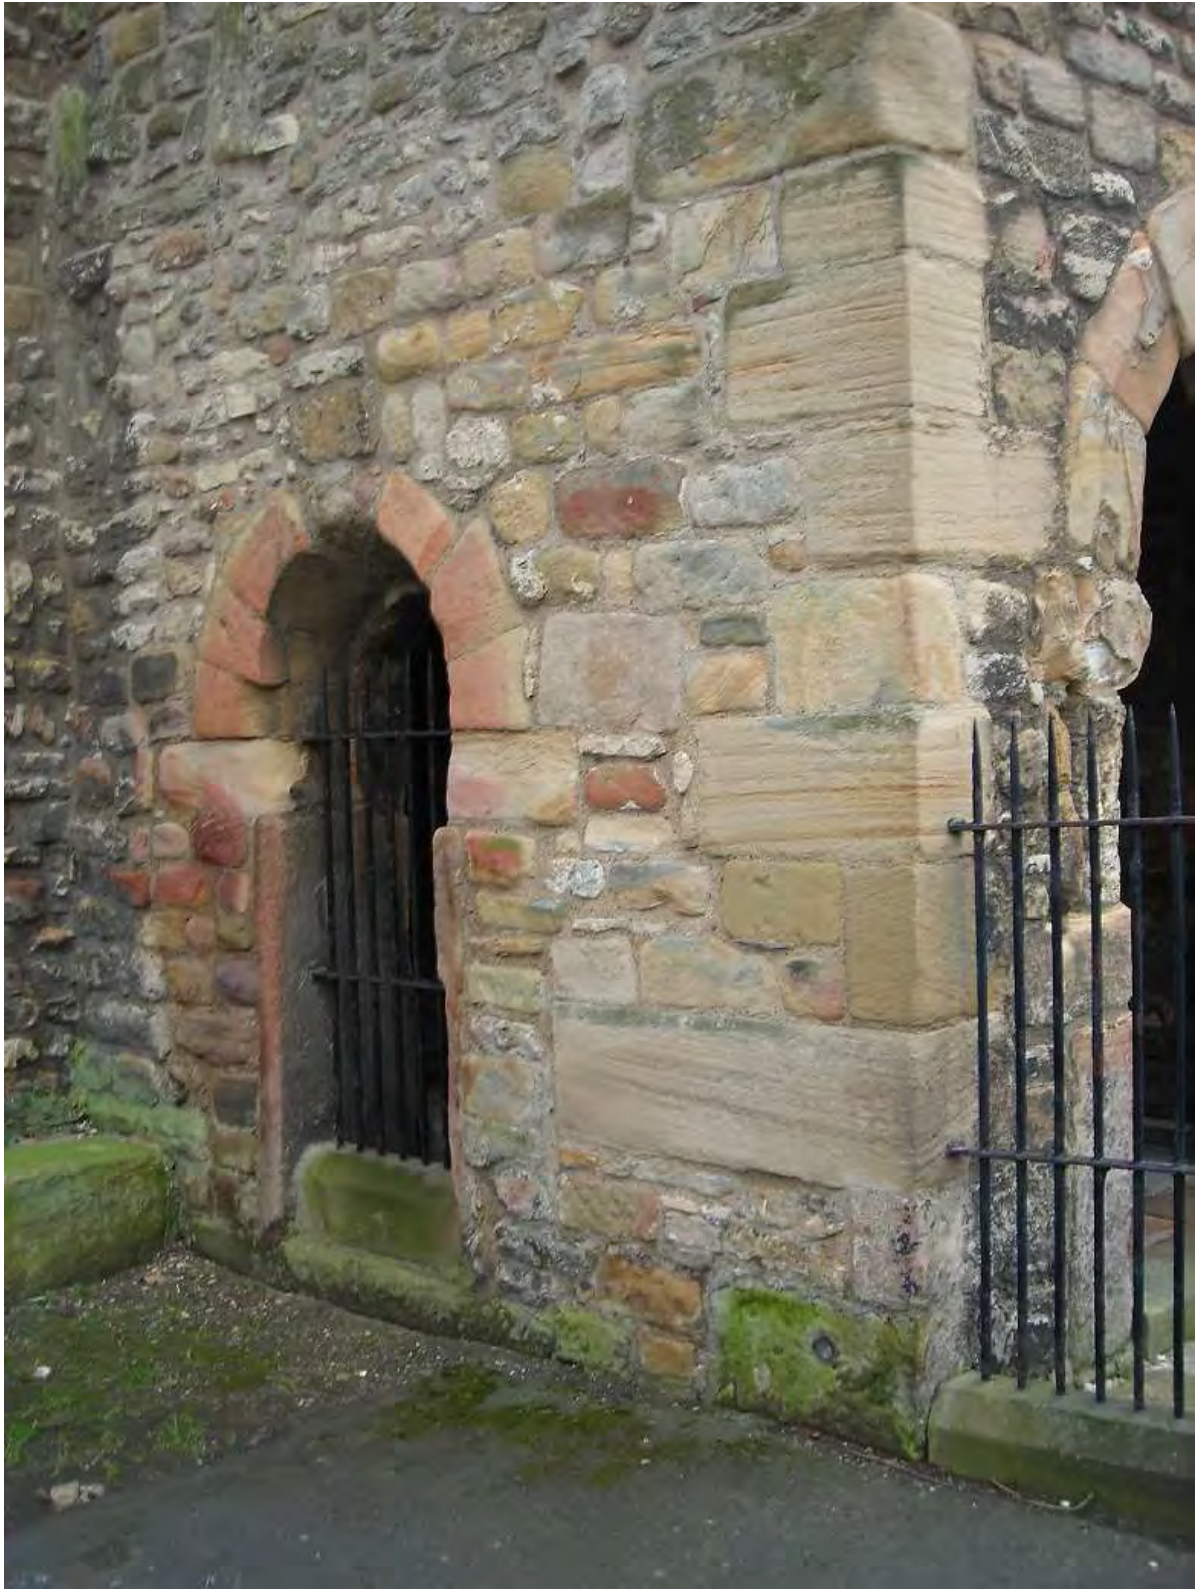
Figure 3a: Entrance on north side of the porch, St. Peter's, Wearmouth. Shows burned ashlar in situ.

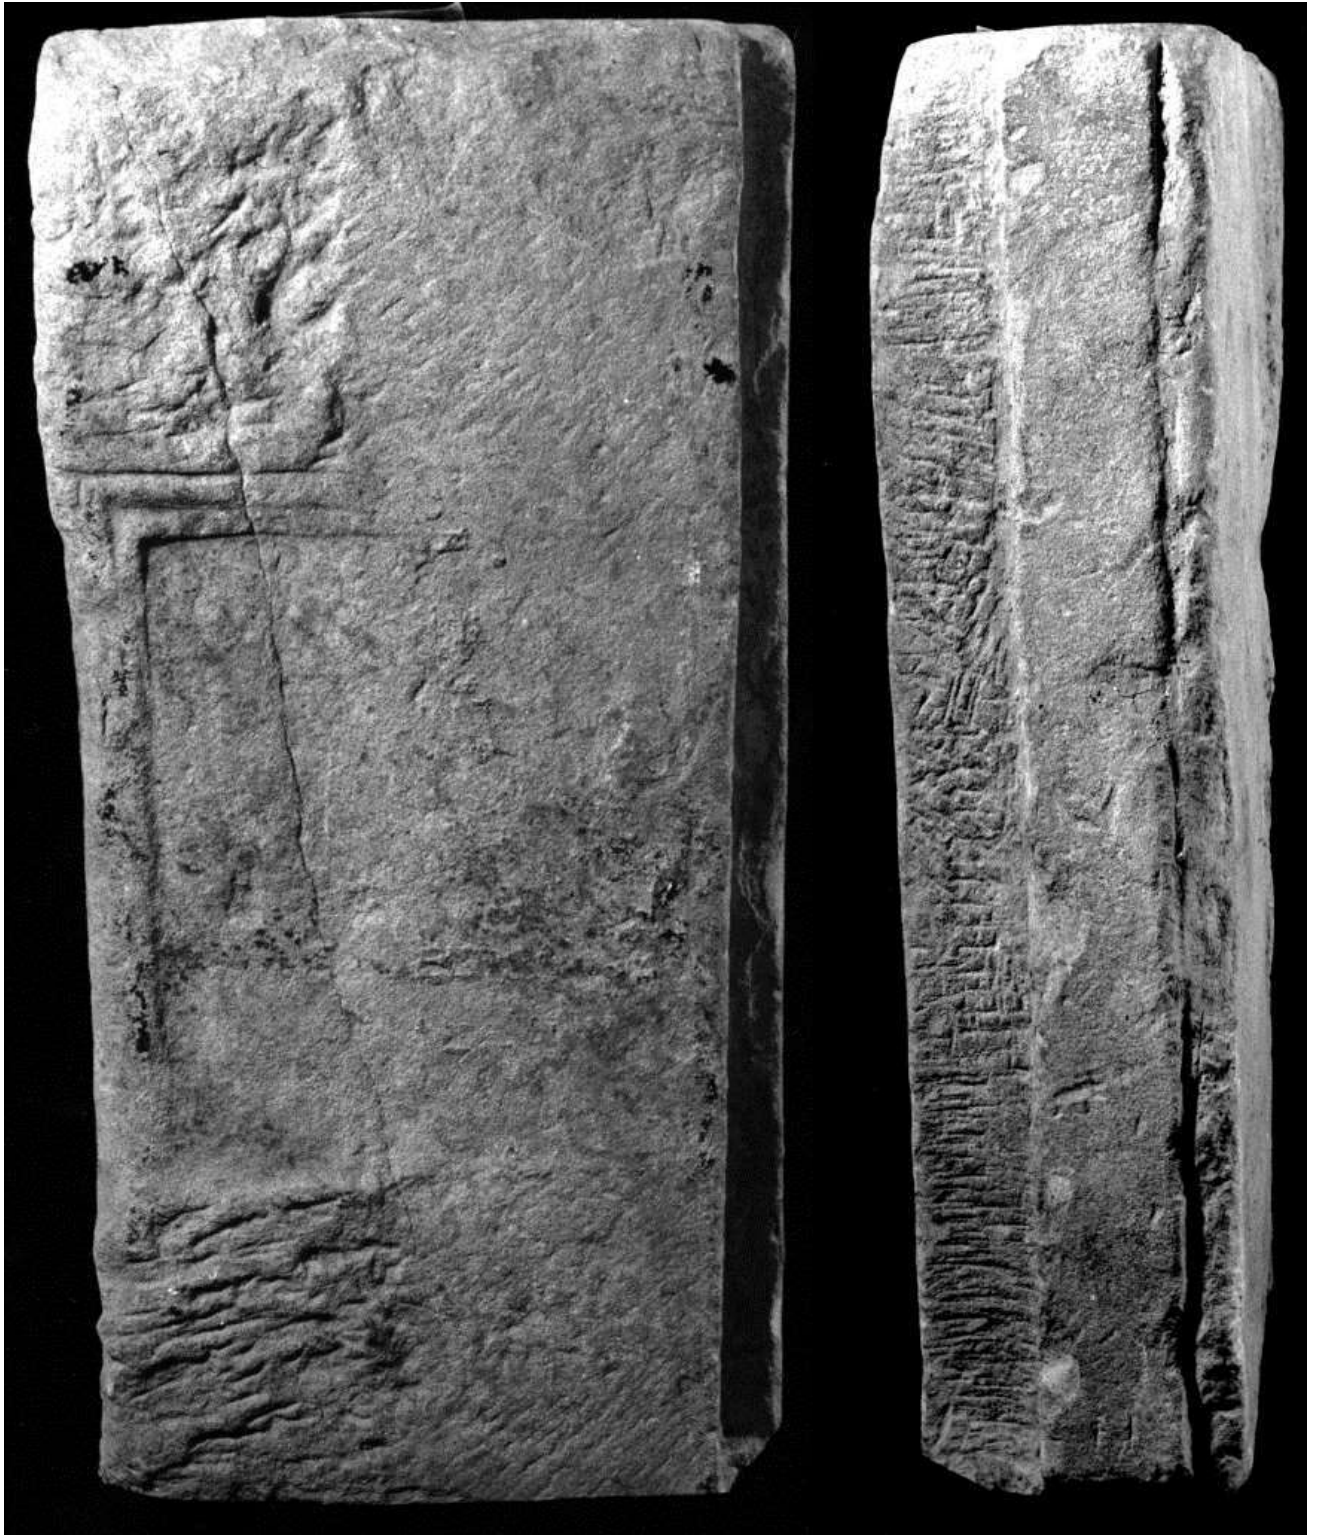
Figure 3b: A door jamb reshaped from a Roman altar, executed in sandstone (Cramp 2006, Fig. 28.2.1, AS1a and b). Reproduced with permission of the Corpus of Anglo-Saxon Stone Sculpture.

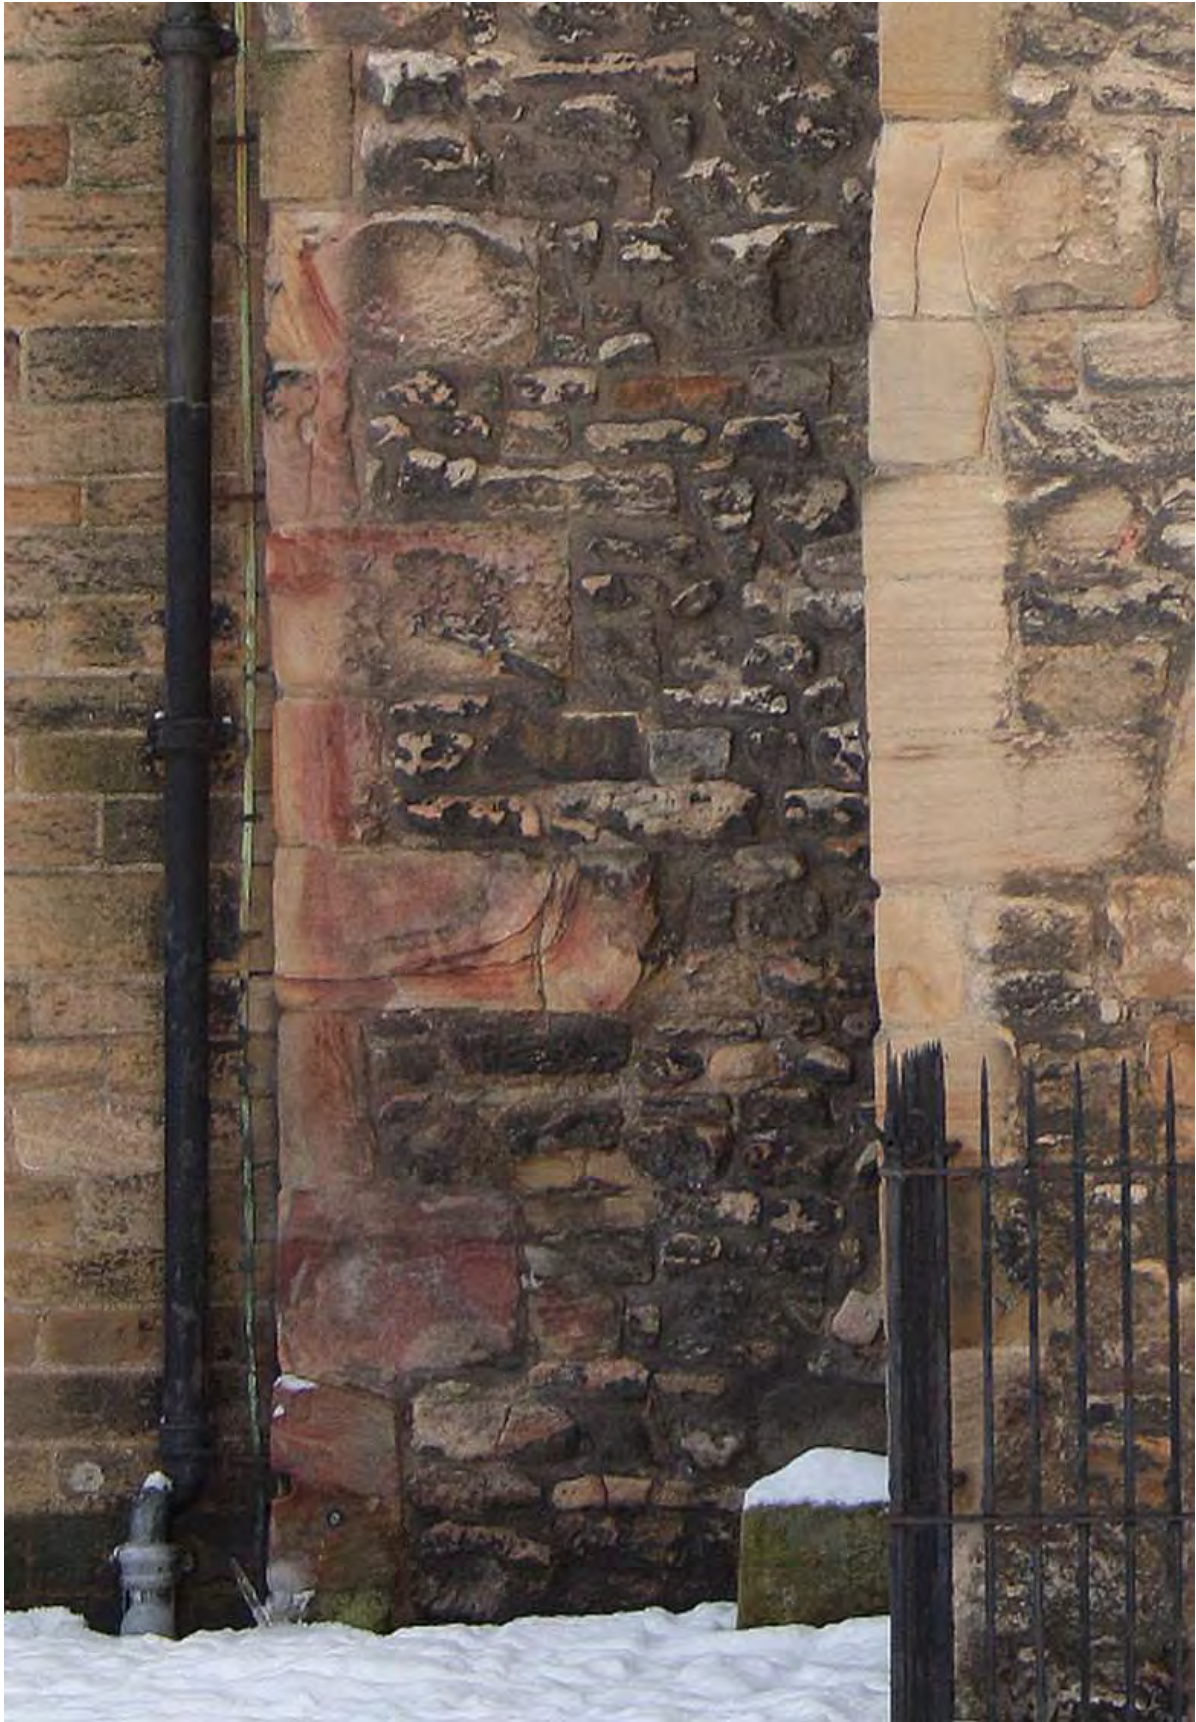
Figure 4: Original quoins at north-west corner of the original nave at St. Peter's, Wearmouth. Note the burned stonework

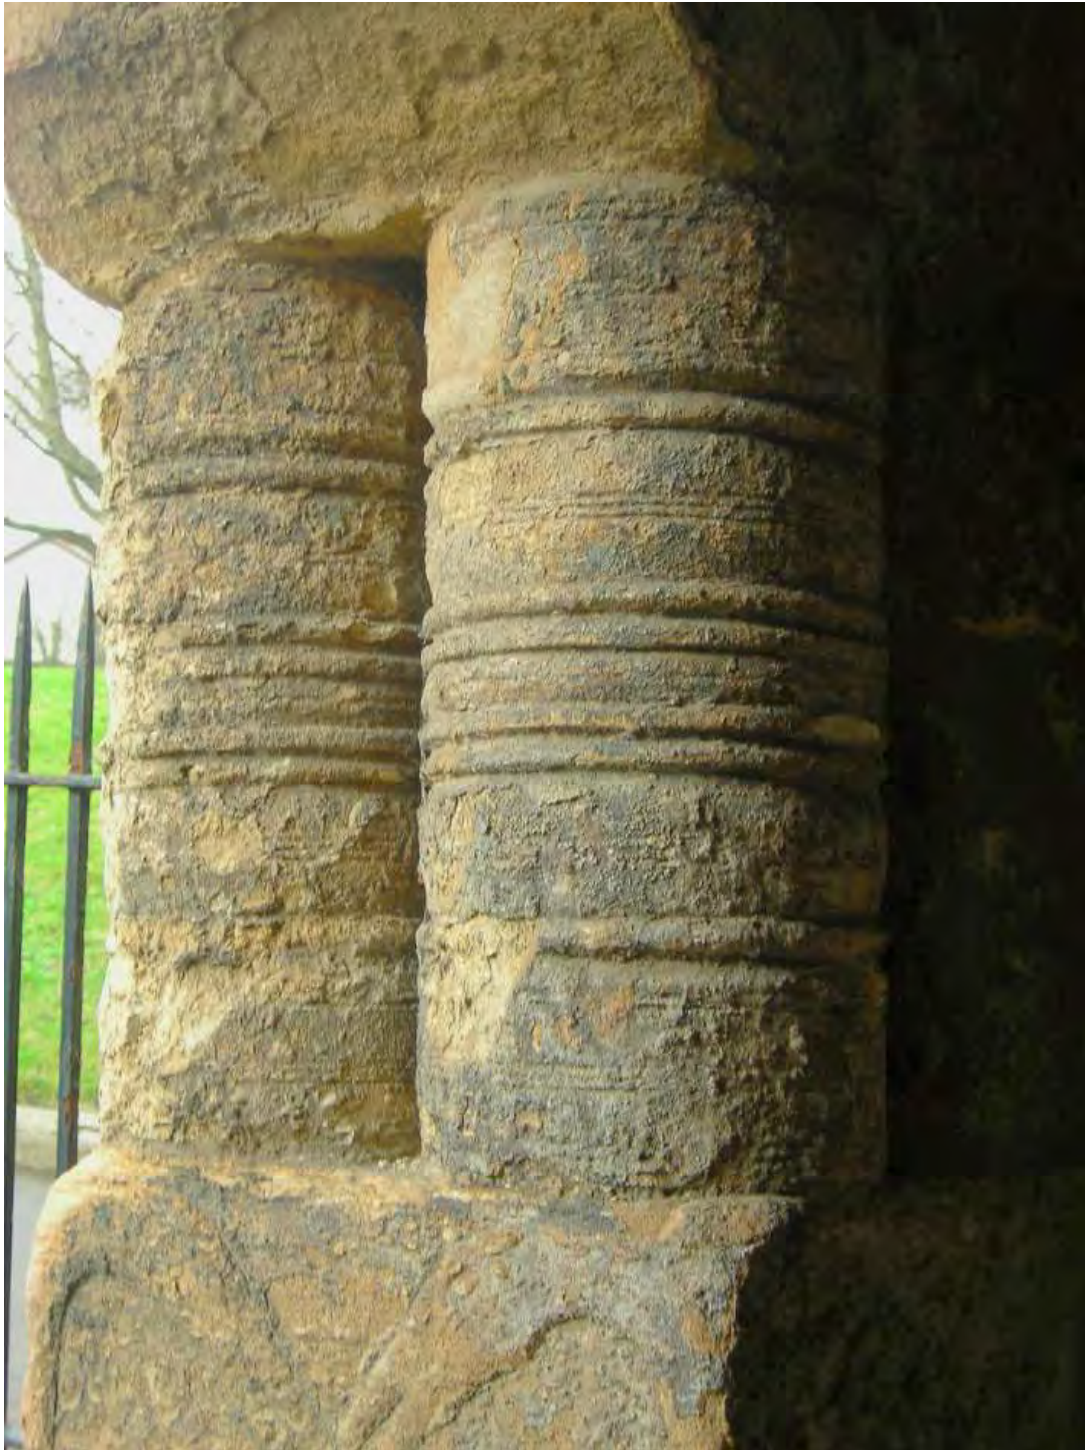
Figure 5: Baluster shafts situated in the porch entrance at St. Peter's, Wearmouth.

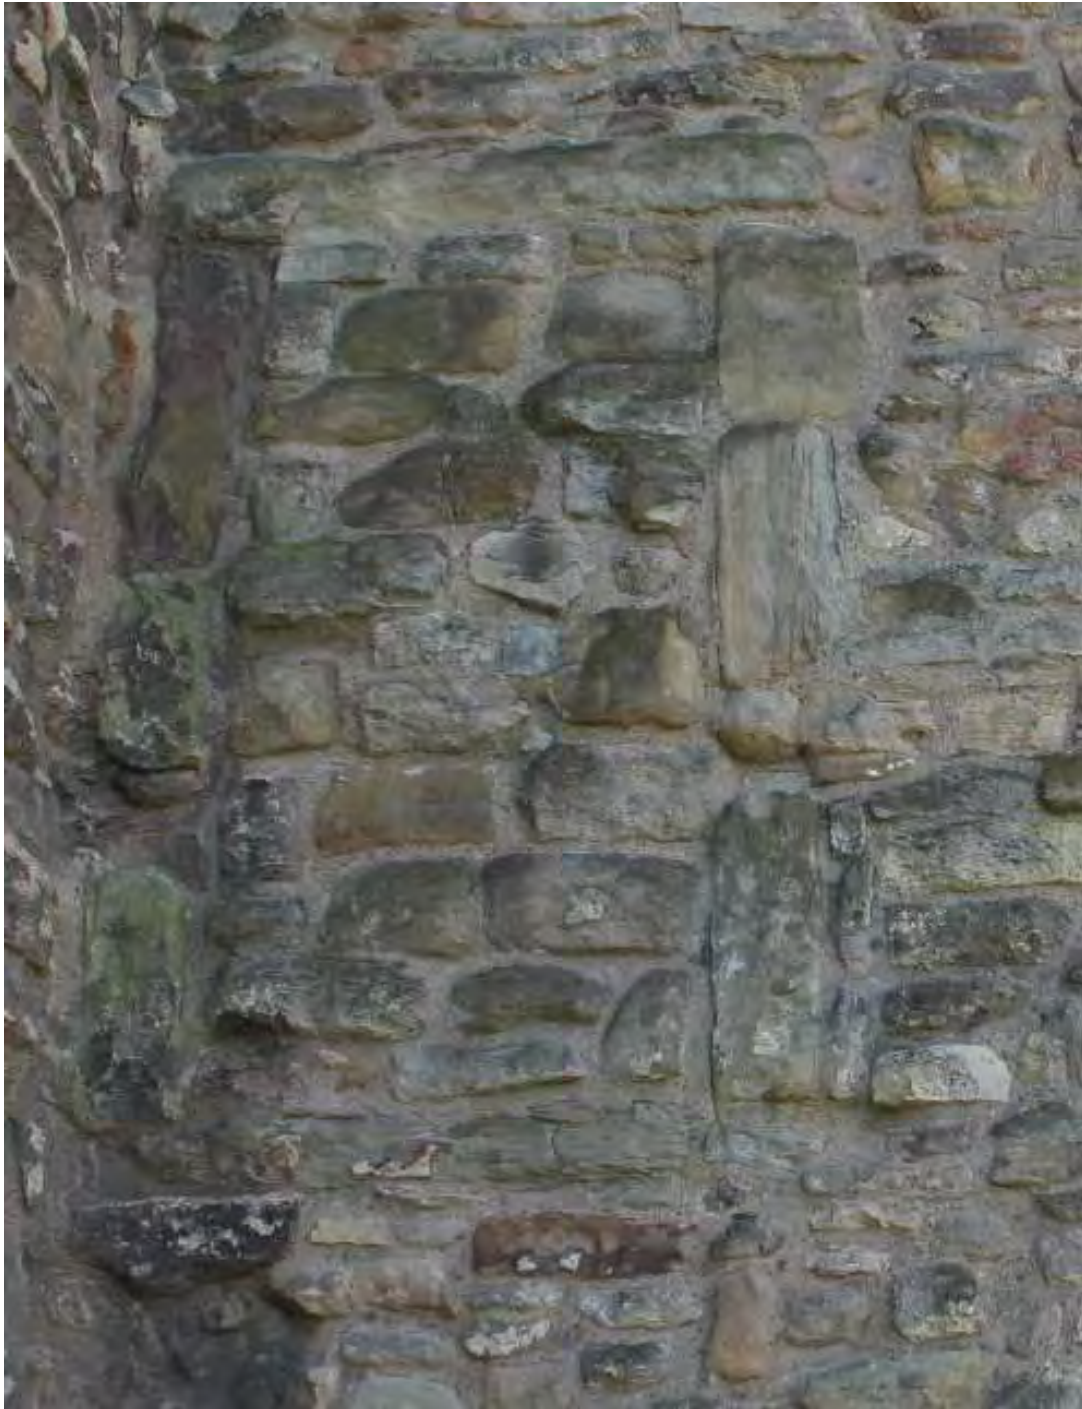
Figure 6: Infilled door with frame on north side of porch/tower, executed in soft sandstone from North Hylton

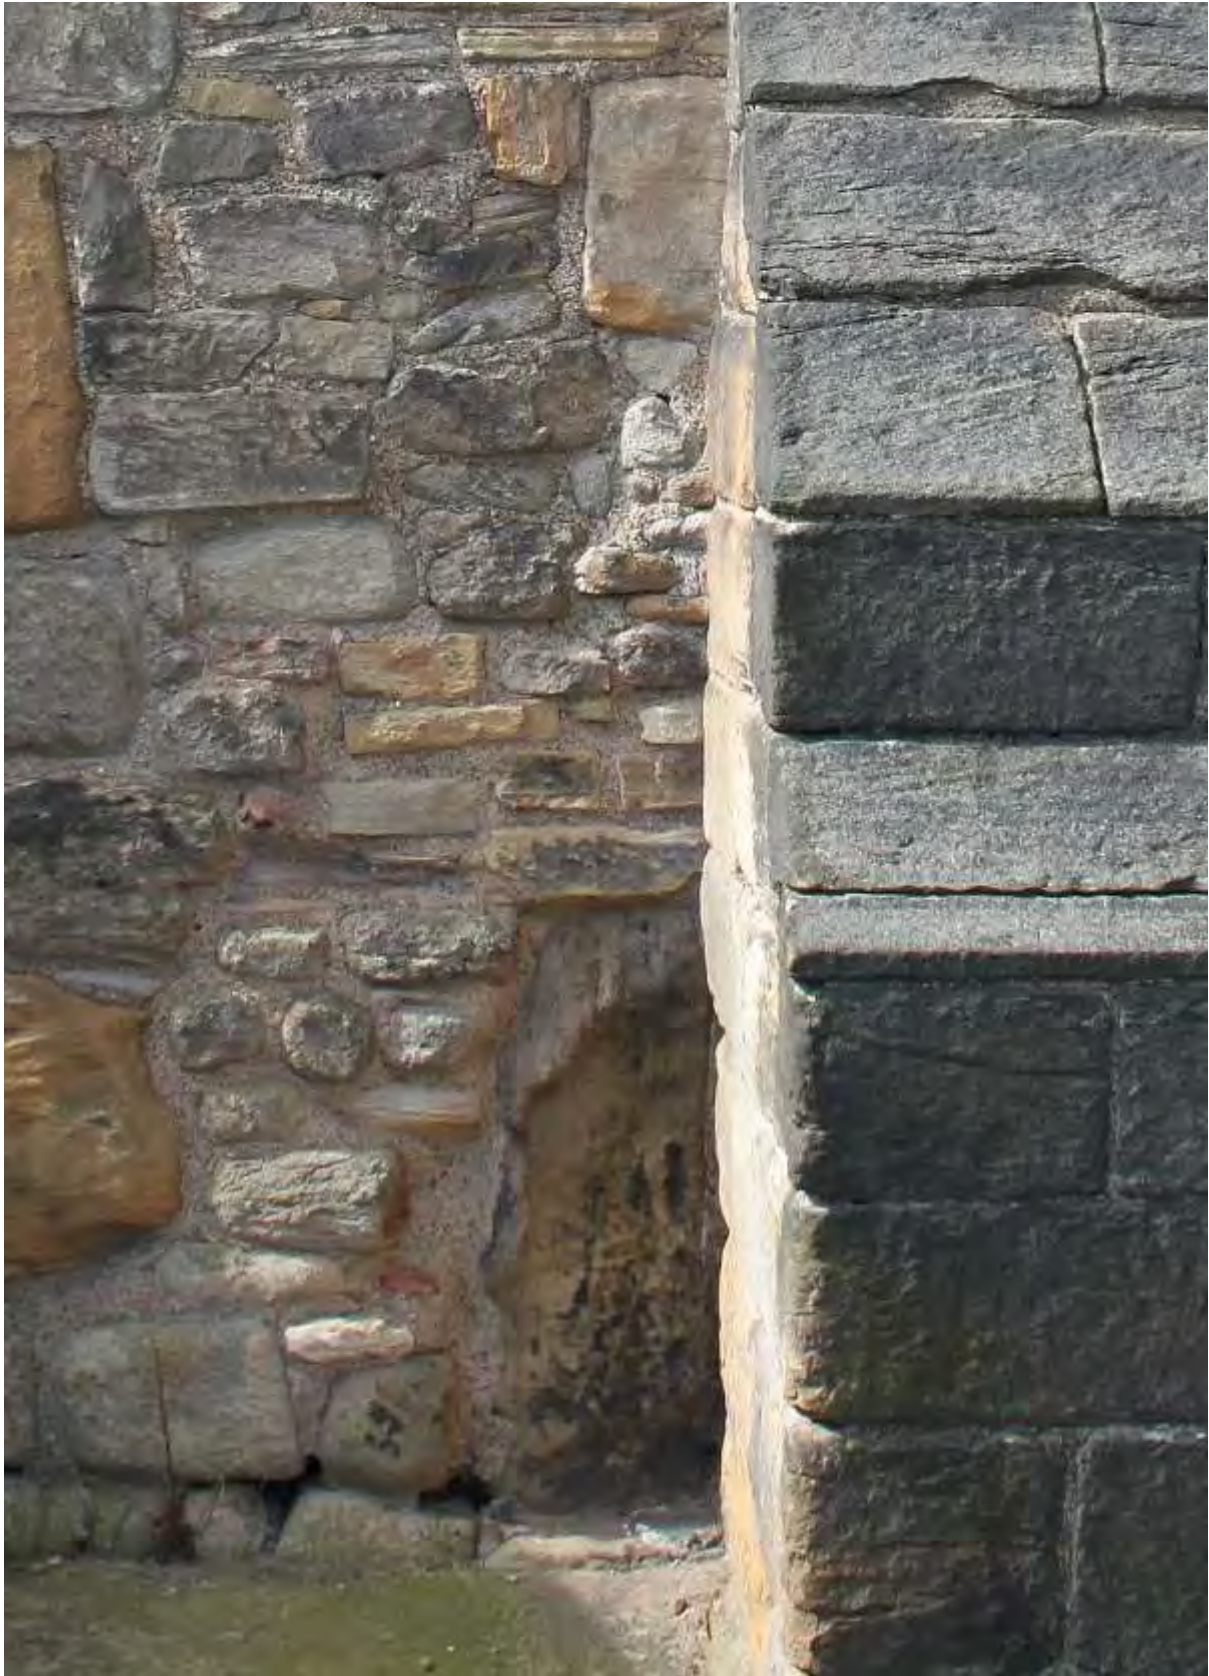
Figure 8: Detail of standing fabric visible externally at the east end of the Eastern Church. The feature is yet to be interpreted. The Type A sandstone is scorched at the base.

Much of the eastern wall of the chancel has been rebuilt or restored over the years owing to foundation problems and the insertion of the large east window. However there are tantalising architectural features, possibly original, at the base of the exterior eastern wall, now partly obscured by more recent buttressing (Cramp 2005, 147-8, 167-8) (Fig 8).

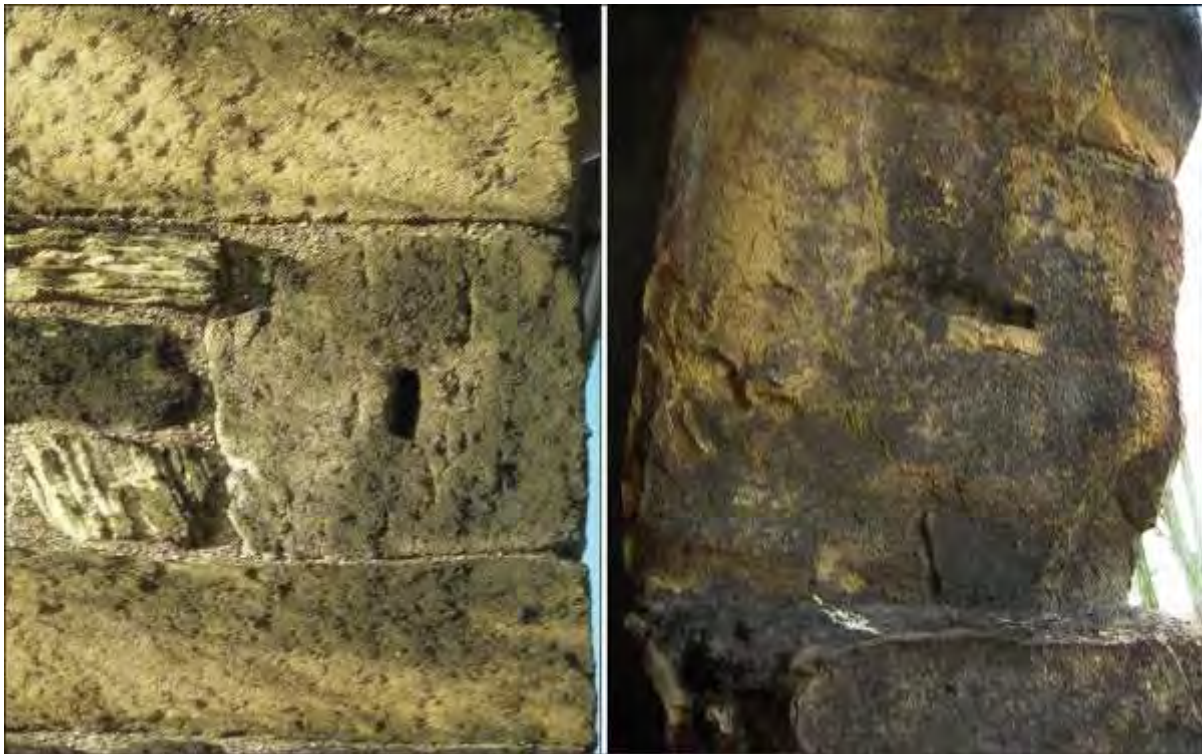
Figure 10: Left: Lewis lifting hole in reused Roman ashlar: quoin at south-east corner of the eastern chapel at Jarrow. Right: Lewis lifting hole in reused Roman ashlar: voussoir on southern side of the western porch entrance at Wearmouth.

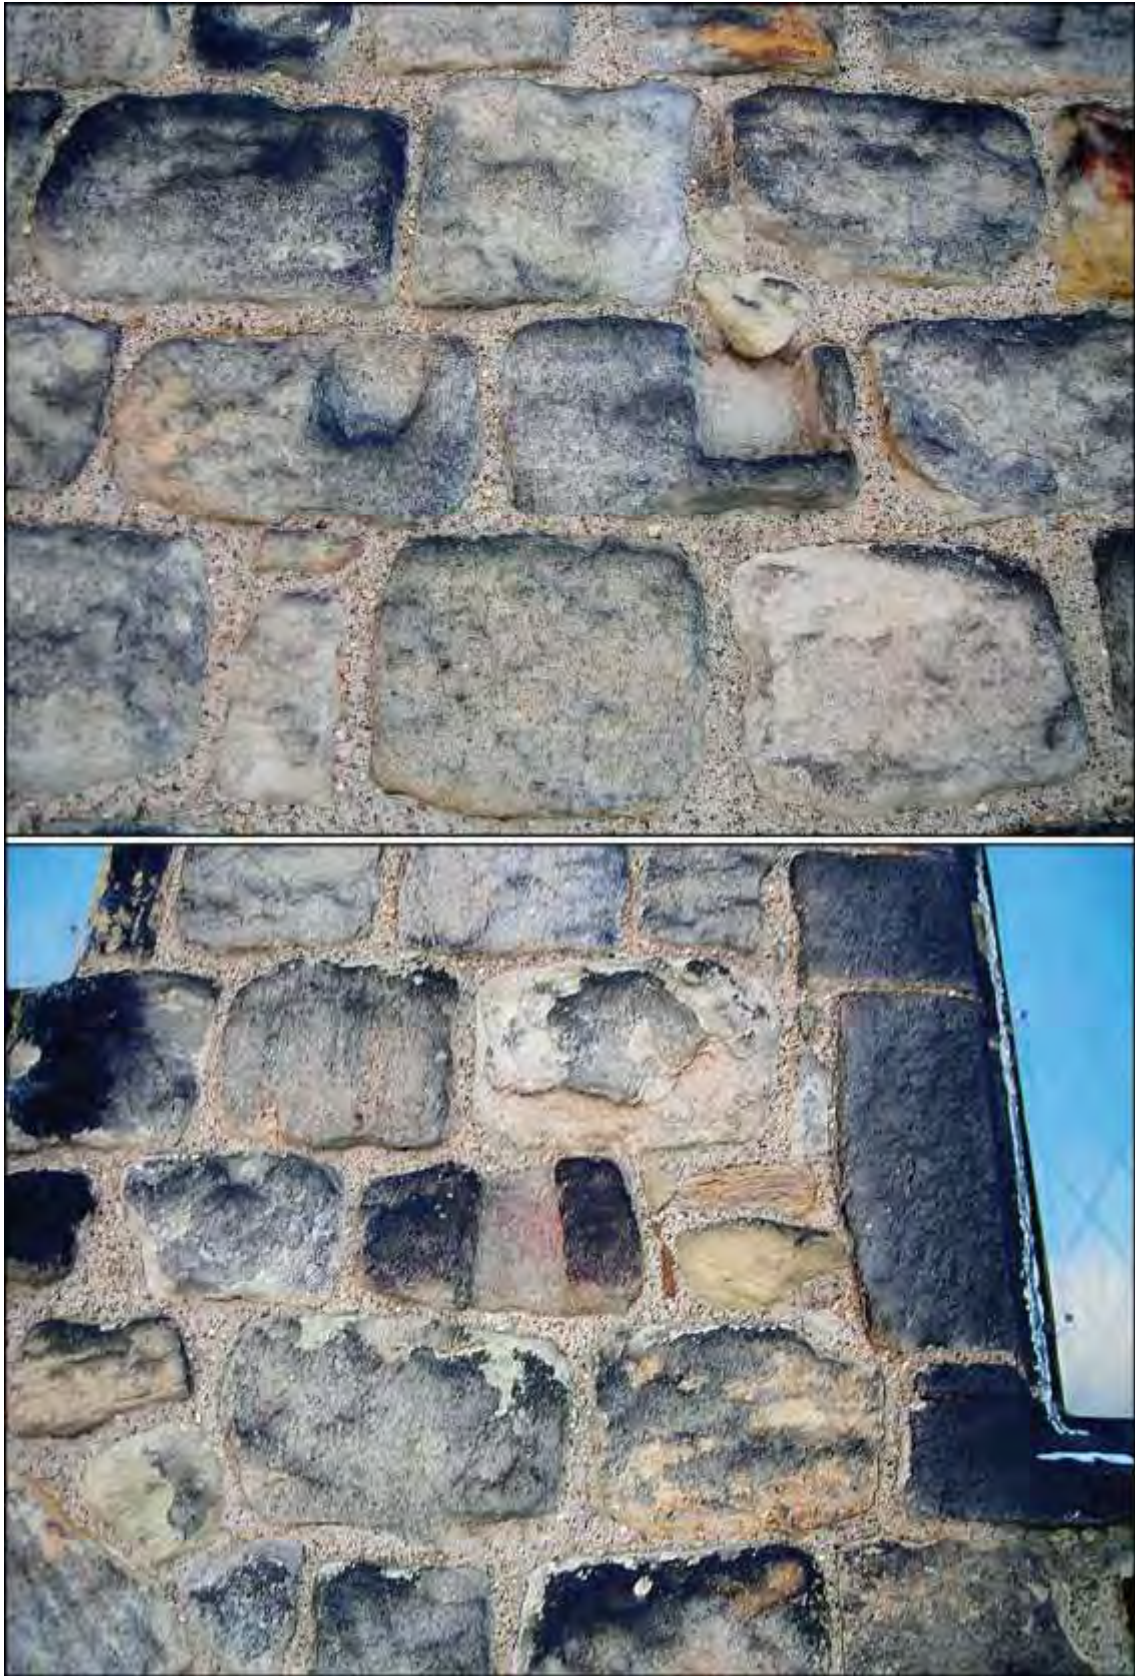
Figure 11: Roman cut mouldings, visible on north external elevation of the Eastern Church at Jarrow.

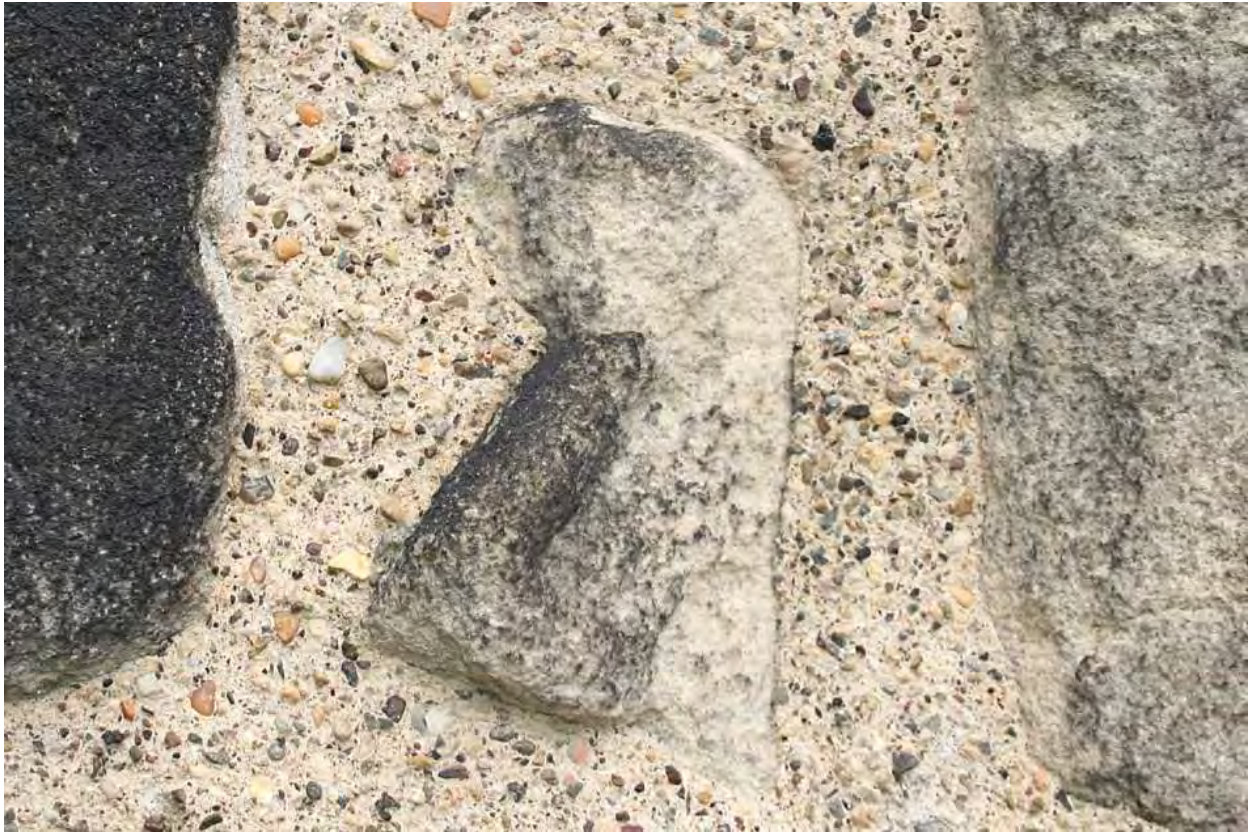
Figure 12a: Roman decorated stone, visible on north external face of Eastern Church, Jarrow.

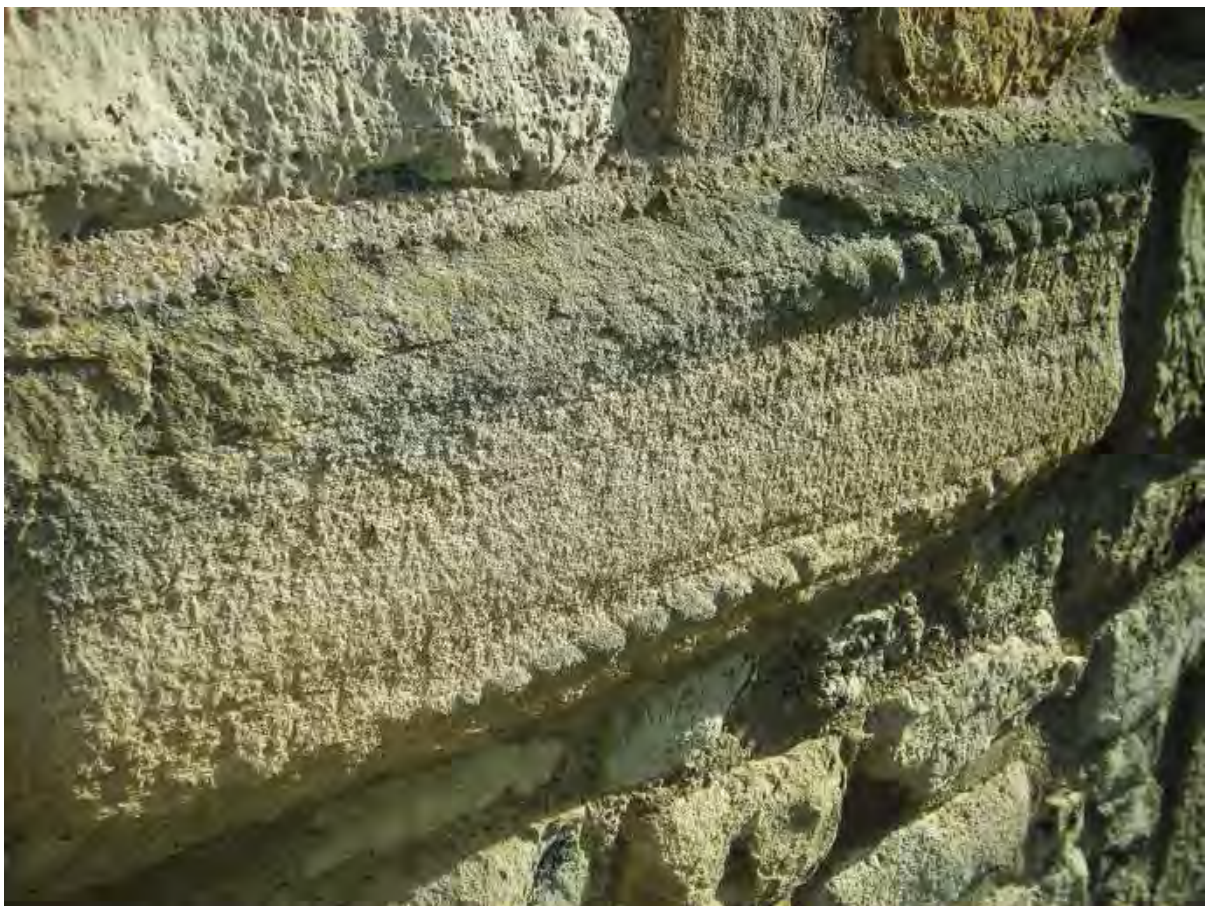
Figure 12b: Roman frieze: strong coursing, west face of porch at St. Peter's, Wearmouth.

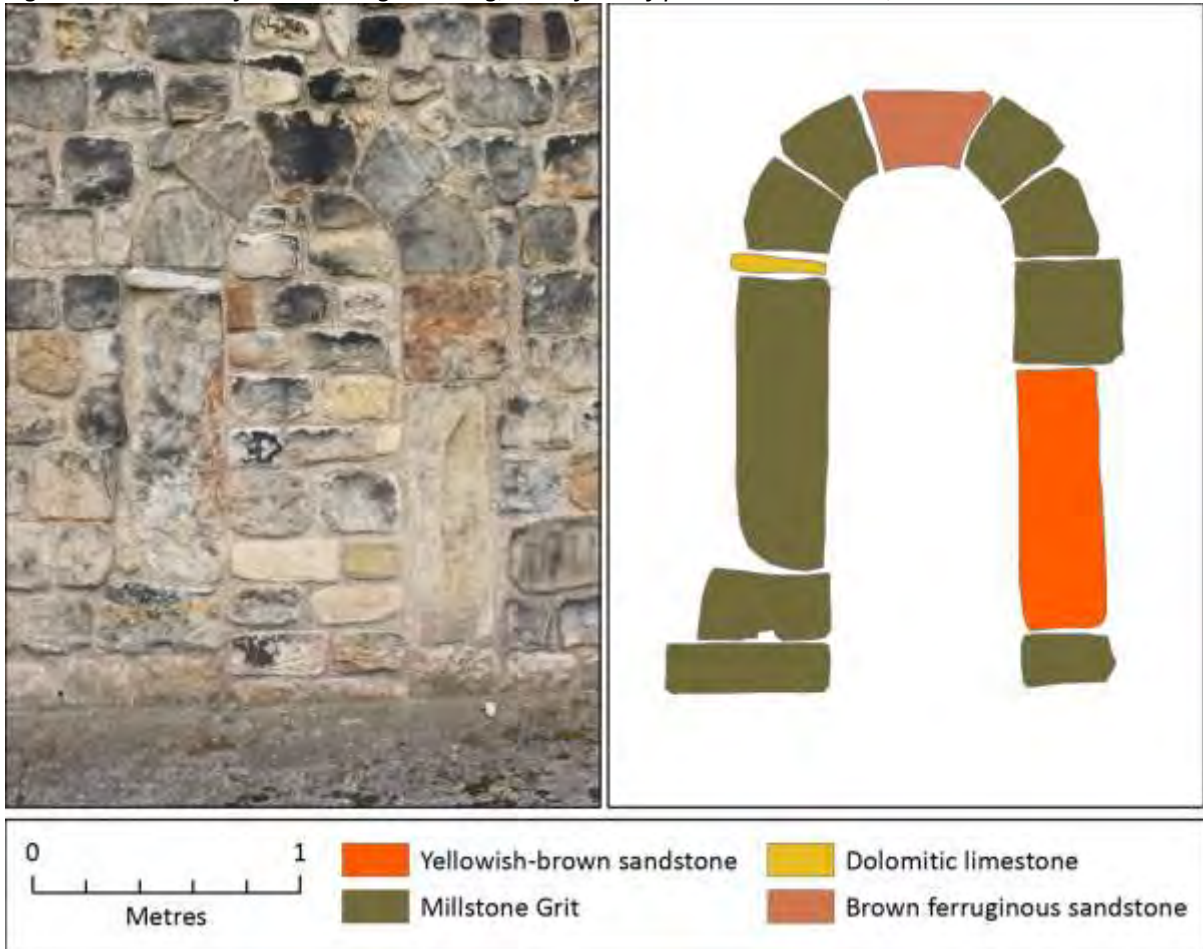
Figure 13: Roman stonework evident in the surround of the blocked doorway on the north side of the Eastern Church at Jarrow.

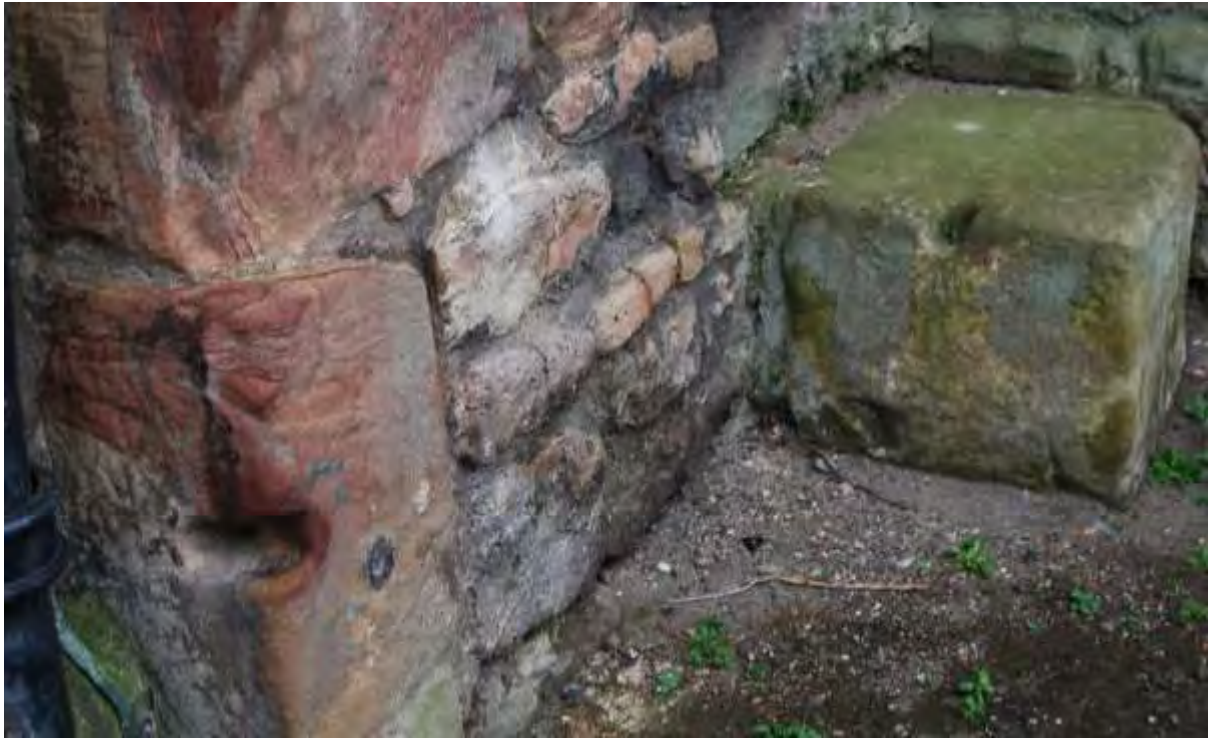
Figure 14: Lewis holes visible in quoin used at the north-west corner of the west external face of the porch at St. Peter's, Wearmouth. The block has been split in two for use in the early medieval building.

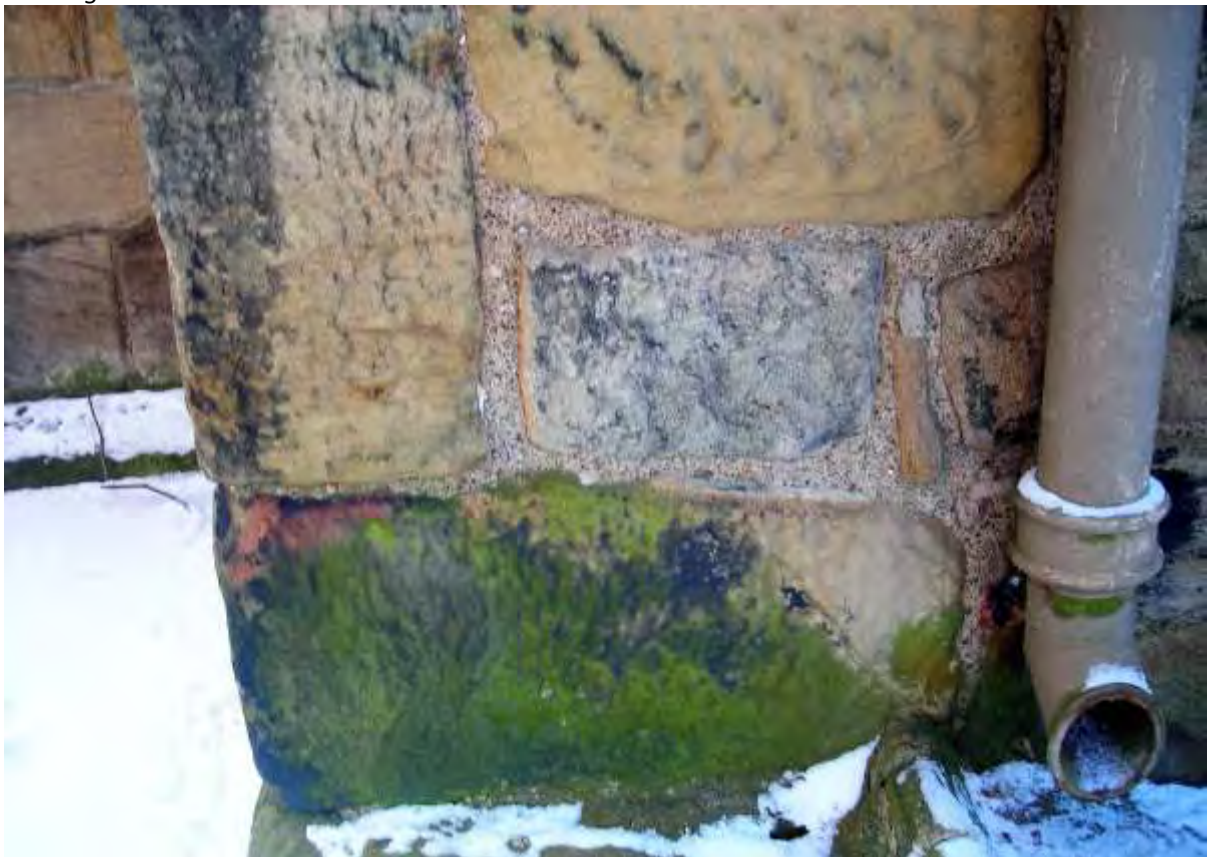
Figure 15: One example of several quoins at both churches, whose shape resembles modified Roman altar stones. This lies at the external south-east corner of the east end St. Paul's, Jarrow.
