Petrological Analysis of the Anglo-Saxon and Anglo-Norman Stonework of St Peter's, Wearmouth and St Paul's, Jarrow

John Senior
With Sarah Semple, Alex Turner and Sam Turner
McCord Centre Report 2014.2

April 2014

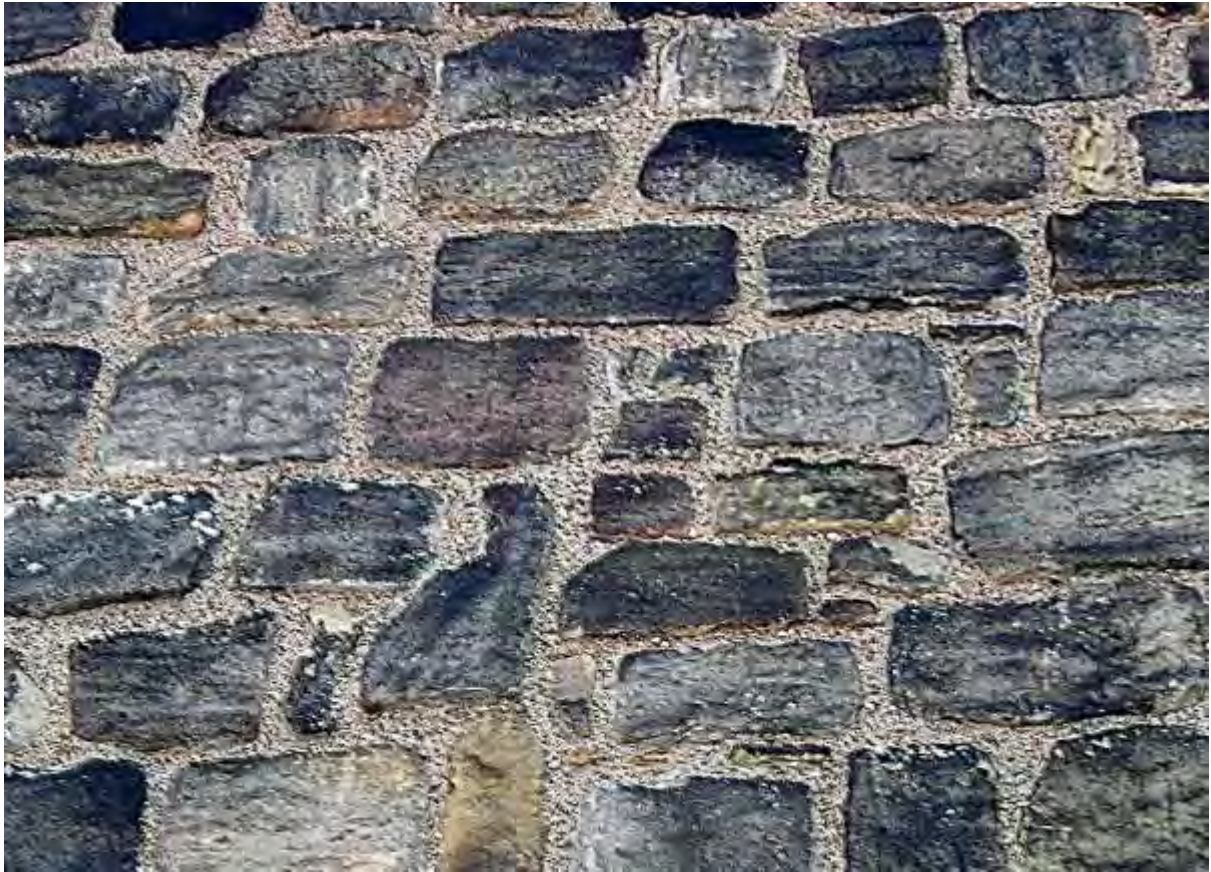
Figure 16: Roman squared building stone – saxa quadrata – west end of the exterior north wall at Jarrow.

What is most noteworthy is the reuse of cut and squared stone blocks or *saxa quadrata* particularly at St Paul’s Jarrow for the general building of walls (Figs 7a and 16). The Romans were efficient organisers with regard to building stone production – especially in military contexts. They had set standards for arch and window sizes and for general building purposes, stone blocks with squared fronts and sides or *saxa quadrata*. These were often standardised with a 24 cm lift height, often with c. 24 x 24 cm squared rubble faces; Fig 17a). Of the Roman sites along the Tyne and Wear, Segedunum seems exceptional in this respect: the evidence is limited but here a c. 15 cm lift height seems to have been the norm (Fig 17b). These stone building blocks seem to have been produced at various conveniently placed quarry sites in large numbers and distributed to the building sites around the Roman North East in finished form, so avoiding the costly transport of stone waste. Although squared off at the front, the sides were left roughly tapering at the back to add building strength to the rubble cored walls (Fig 18). *Saxa quadrata* could be lifted easily by wall builders and rapid construction was possible. Most of the Anglo-Saxon and Anglo-Norman interior and exterior walls at St Paul’s have been constructed using these standard Roman building units. At St Peter’s Wearmouth, there is some use of squared stone blocks in the Anglo-Saxon walls, but the bulk is constructed using newly quarried Magnesian Limestone (Roker Dolomite) rubble. By contrast, there is considerable use of squared Roman ashlar in the Anglo-Norman upper lifts of the tower/porch at St Peter’s (Figs 1 and 19).

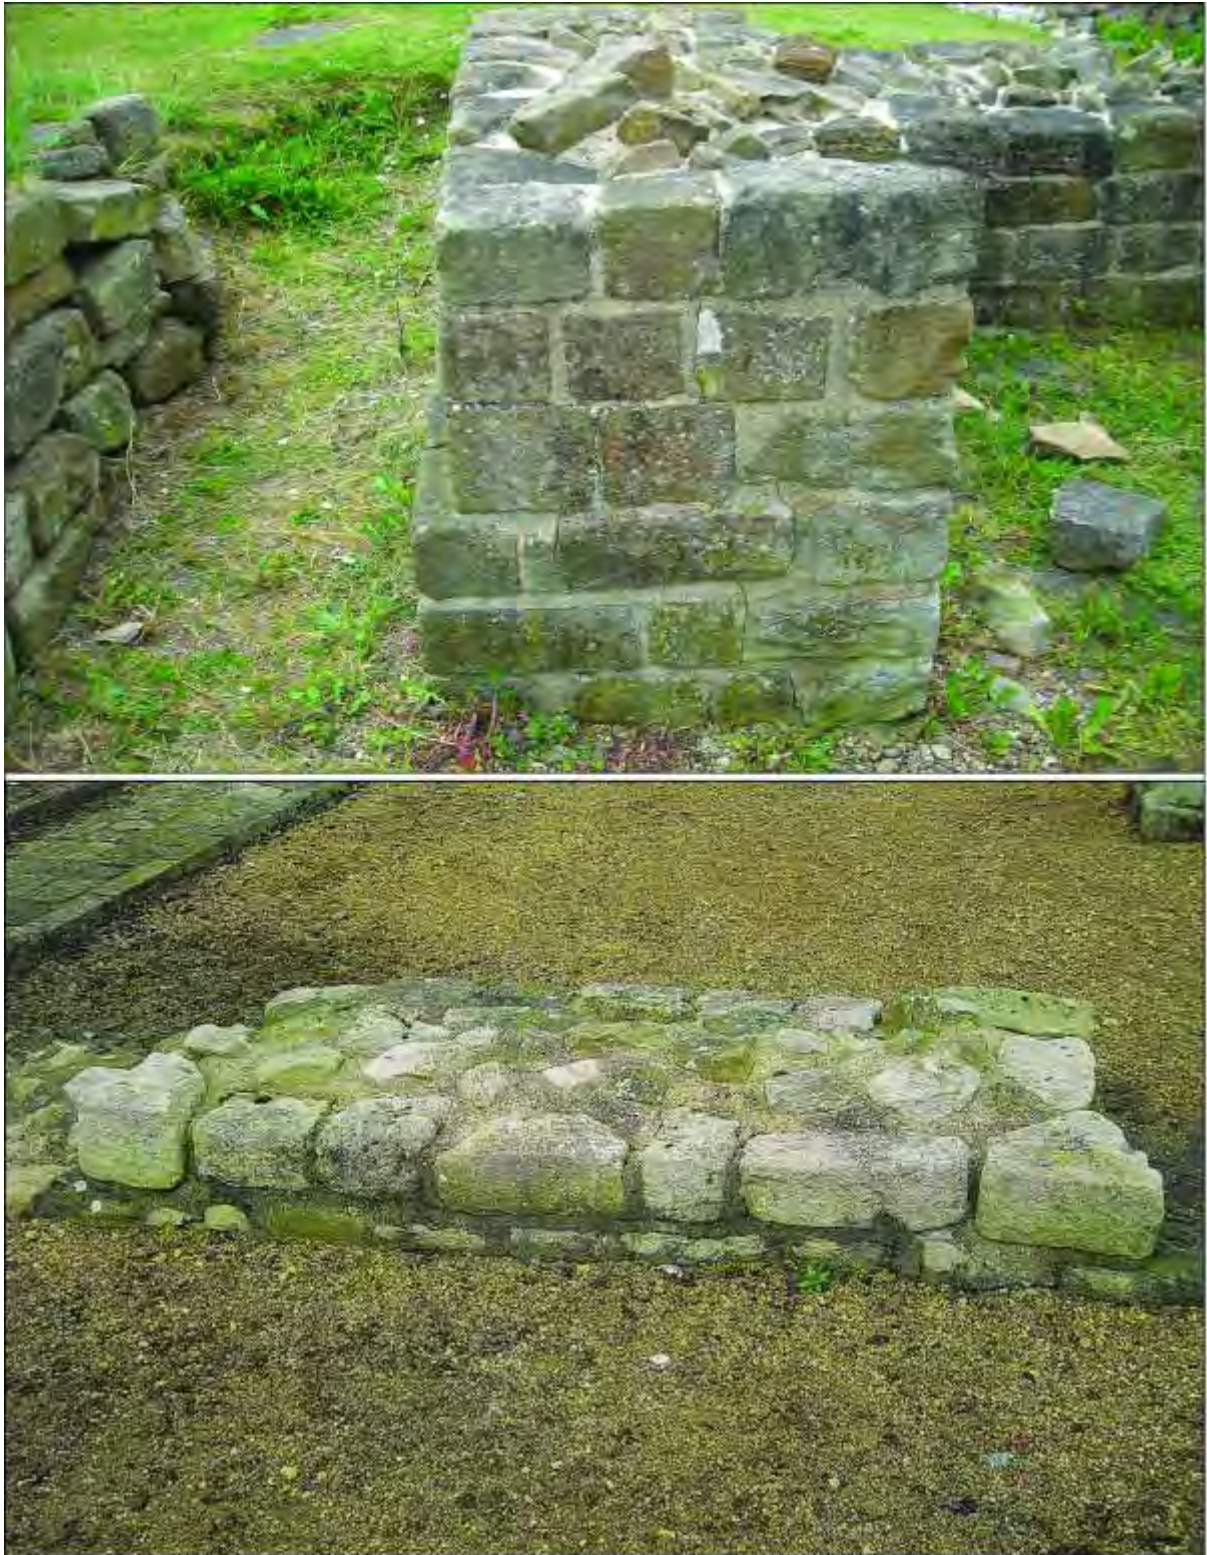
Figure 17: Top: Arbeia: standard 25 x 25 x 25cm squared ashlar executed in Wrekenton Sandstone. Bottom: Segedunum: squared rubble walling executed in Millstone Grit with a lift height of c. 15 cm

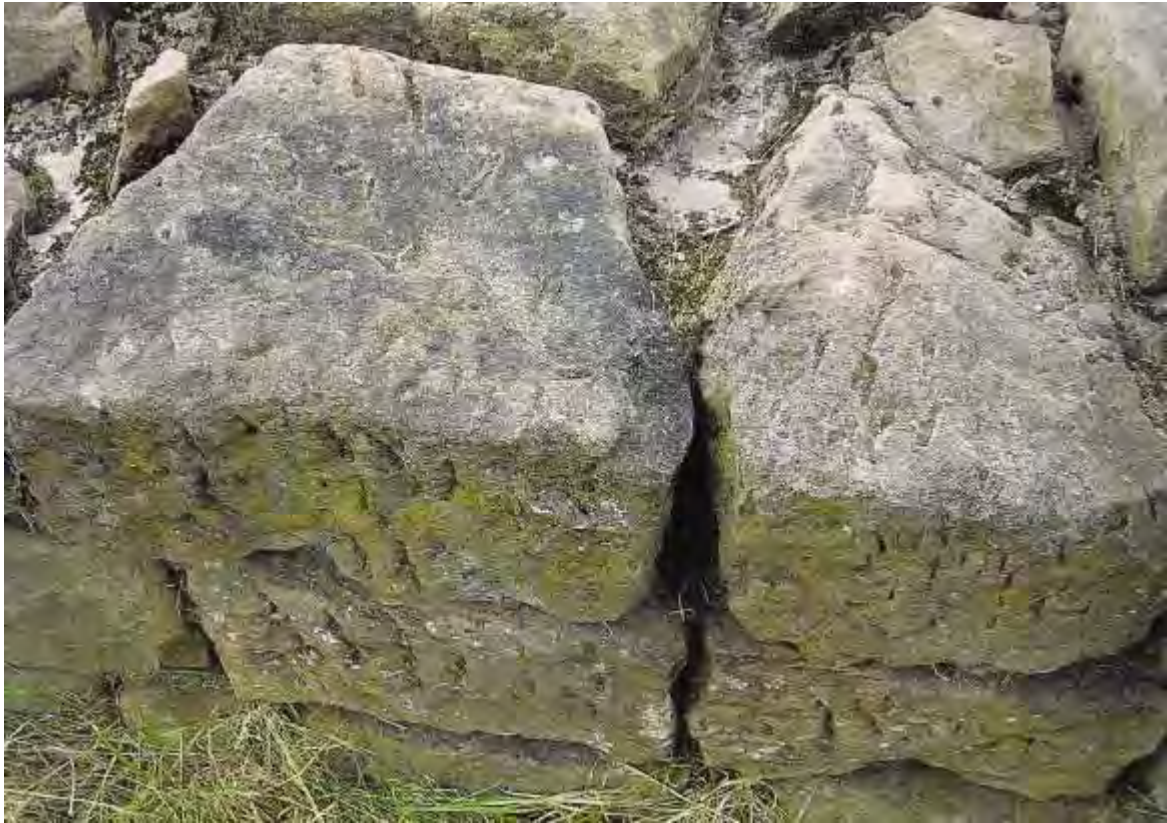
Figure 18: Arbeia: example of squared rubble blocks executed in Wrekenton Sandstone with a c. 25 cm lift height and tapered backs.

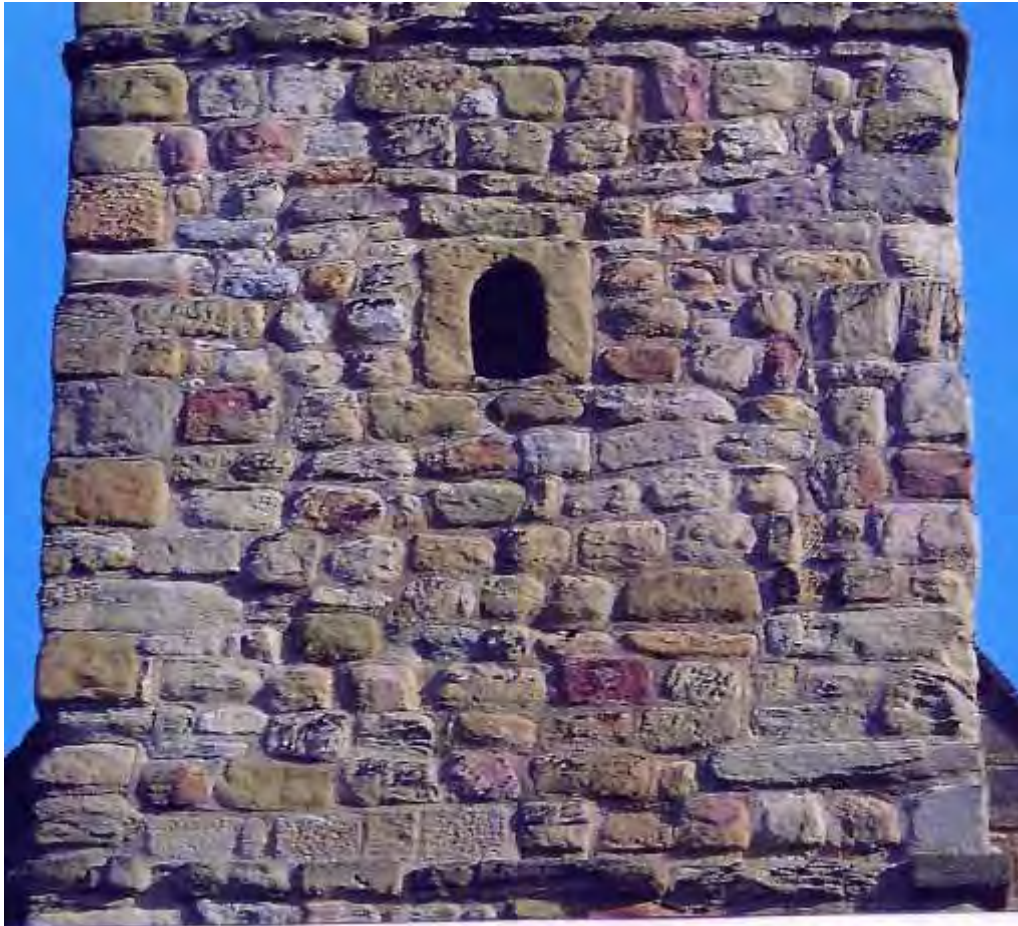
Figure 19: The 11th-century tower at St. Peter's, Wearmouth: not the extensive use of Roman squared stone, largely executed in Wrekenton sandstone.

Recorded: This stone type has been used in the fabric of St Peter's, Wearmouth (and St Paul's, Jarrow in the pre-Conquest and Anglo-Norman fabric. It is extensively used at Arbeia, South Shields in 4th and 5th century contexts (Fig 19a) and at Segedunum, but here taken from local Wallsend area quarry sources.

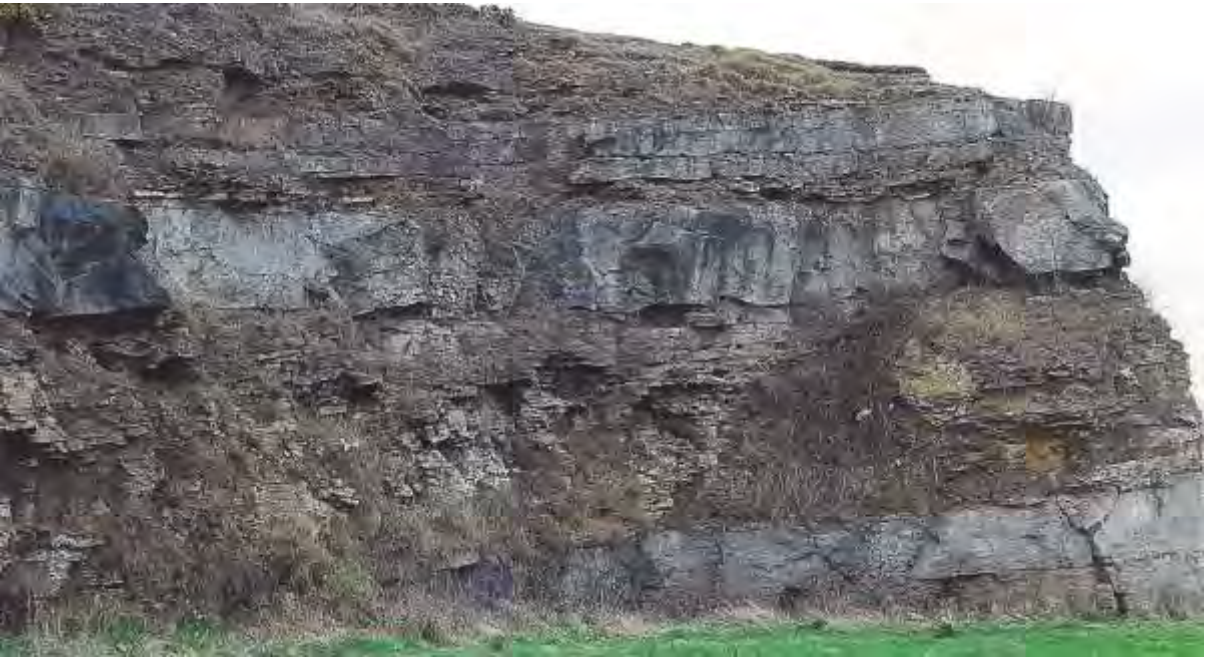
Figure 21a: Most recent part of the Marsden Quarry in the eastern Cleadon Hills (NZ 359 644). The Roker Dolomite (Upper Permian) of this area provided stone for parts of the Arbeia supply fort.

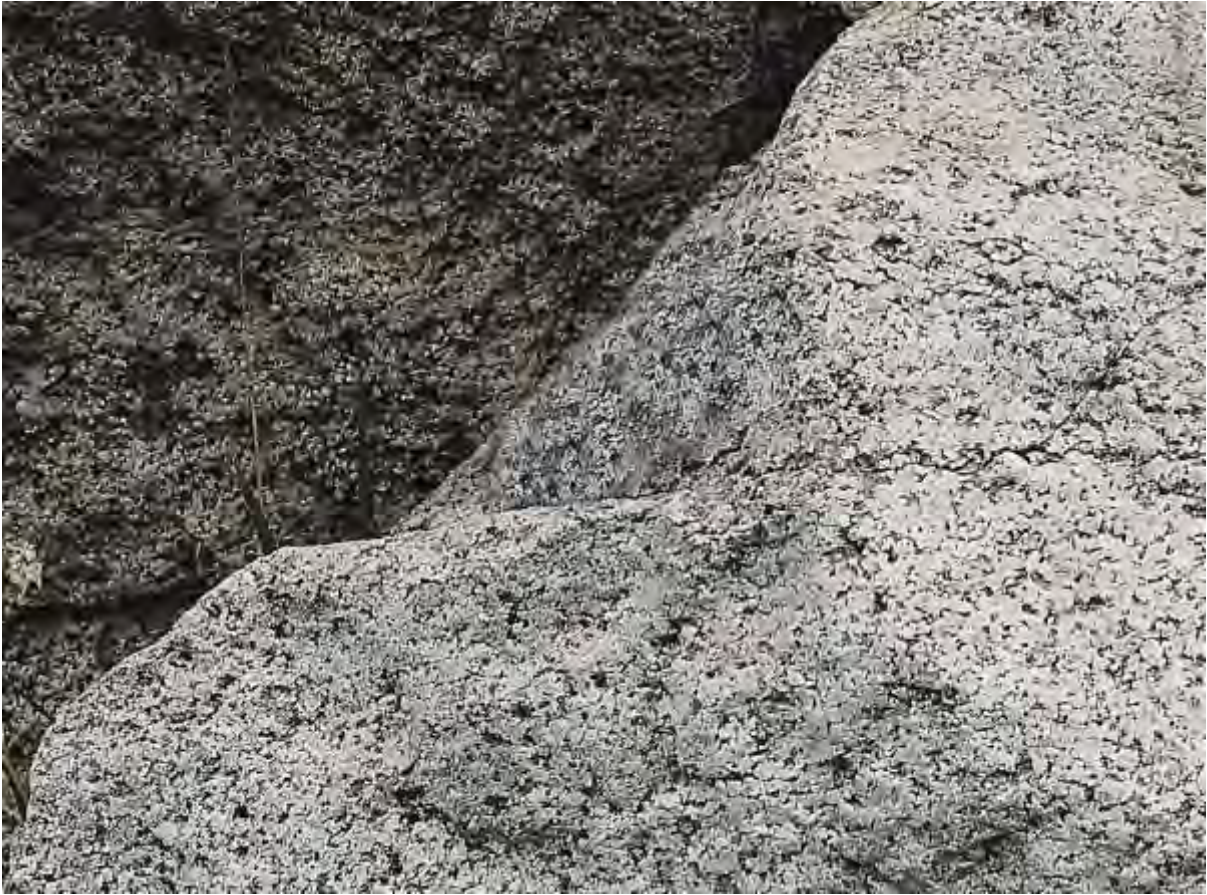
Figure 21b: Coarsely crystalline dolomitic limestone at the Marsden Old Quarry.

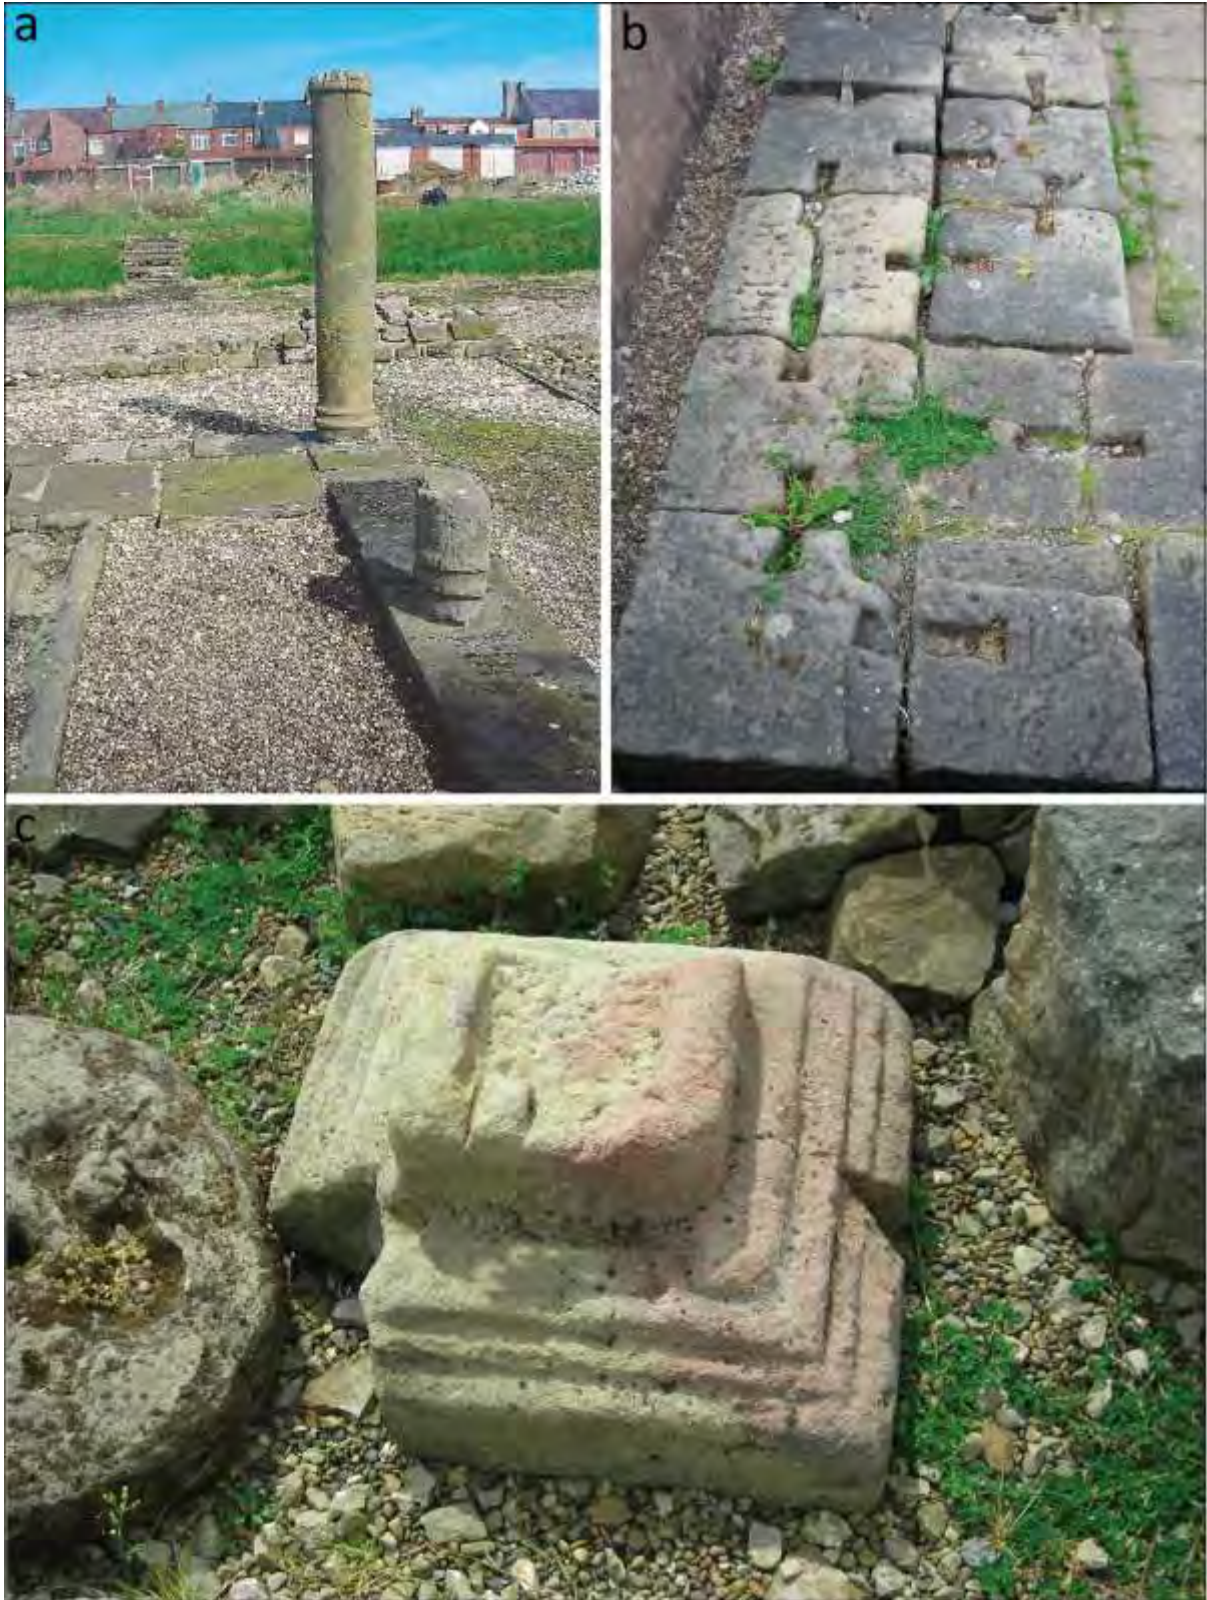
Figure 22a-c: The colonnade shafts of the Headquarters Building Missing – new photo needed; b) Footing of colonnade shaft, note the partial burning of the stone; c) Strong-room blocks beneath the Headquarters Building.

Illustrations: Photomicrographs Fig 45a (Heddon-on-the-Wall), 45b (St Paul's, Jarrow), 45c (Roman Strongroom), Arbeia; Arbeia (Fig 22); Heddon-on-the-Wall (Fig 23); St Paul's, Jarrow (Fig 42a-c); St Peter's, Wearmouth (Fig 1).

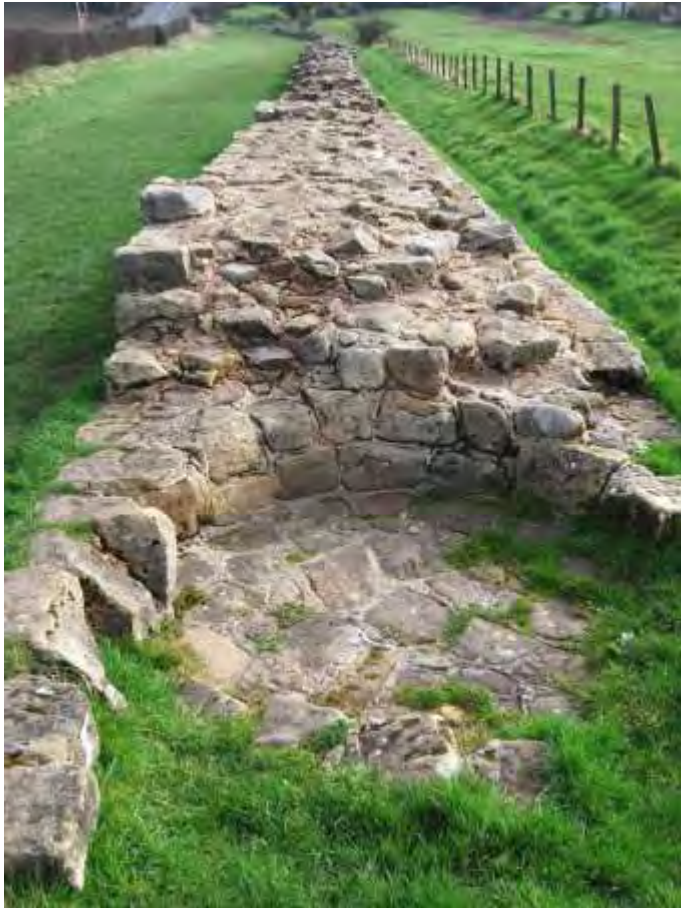
Figure 23: Roman Wall section at Heddon-on-the-Wall, constructed with local Millstone Grit ('Third Grit' Lower Carboniferous; NZ 130668).

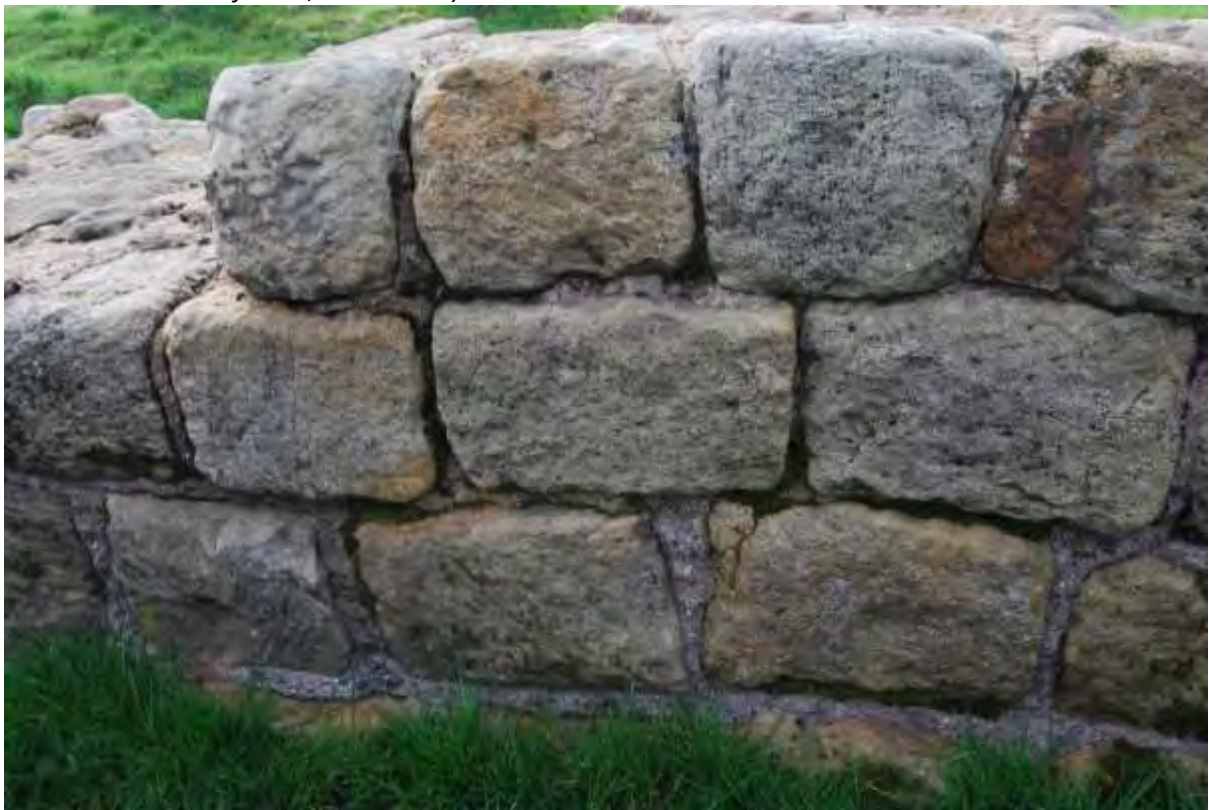
Figure 24: Heddon-on-the-Wall: squared rubble walling. Note the c. 30 cm lift dimension.

The Romans civil engineers developed a tradition of using coarse grained sandstones and Millstone Grits for special building purposes. For example at York (Eboracum), Millstone Grit formed the foundations and footings of many walls and buildings, since it is durable and resistant to damp. The use of this material at Arbeia and elsewhere is not surprising: it was used contemporaneously with the Magnesian Limestone (used for the granaries), in the colonnades of the Headquarters building (Figs 22a and b), the drains and the huge strong-room blocks beneath the *Sacellum* (Fig 22c) and elsewhere. This stone was brought to the site along the River Tyne probably from the Heddon-on-the-Wall area where it was also used extensively to construct the Roman Wall (Fig 23). The quarries (NZ 130668) exploited the 'Third Grit' on the north side of the Tyne valley (Mills and Holliday 1988) and lay very close to the river which would have been navigable to shallow draft craft. There is some indication that these ashlar pieces, some of which were very large (Fig 22c) would have been cut and finished at the quarry site (to avoid the cost in time and effort transporting waste stone) and then transported to the place of use. Some of the ashlar units show a standard square-faced pattern and may have been produced in bulk for use at various fort sites and construction of the Wall (Fig 24).

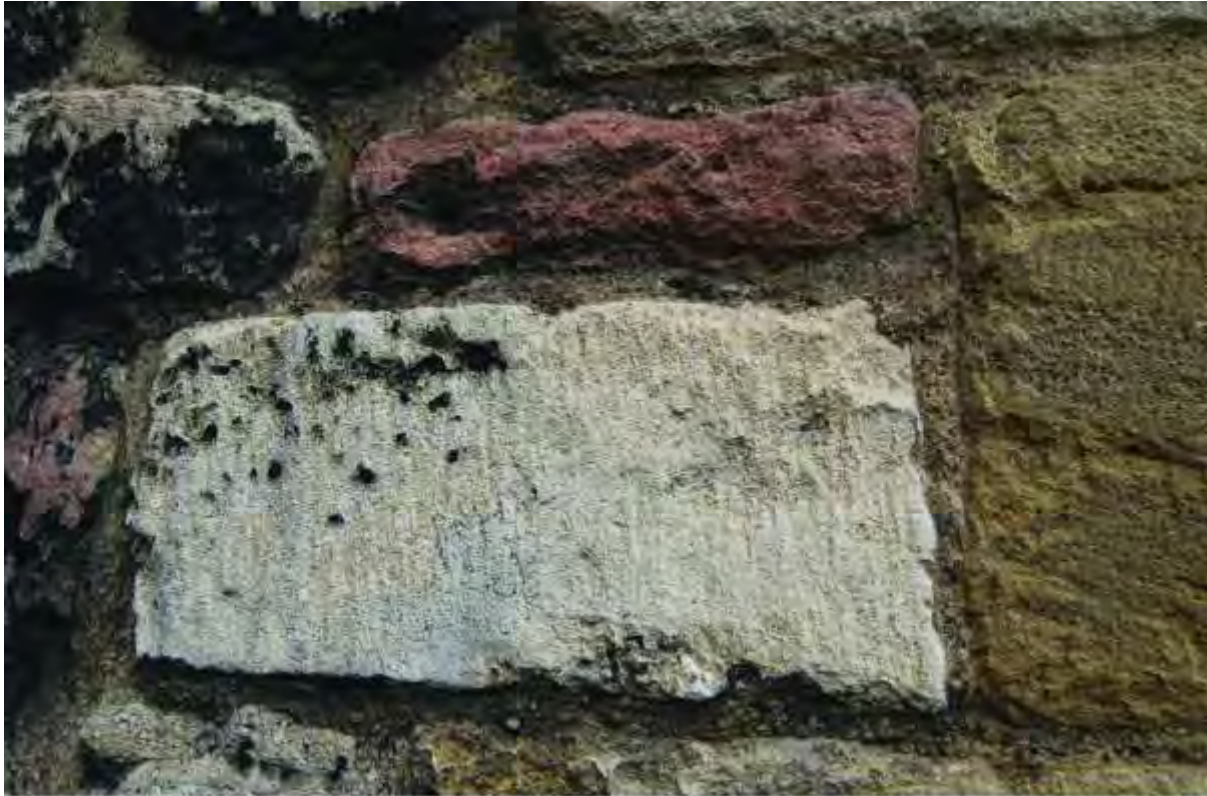
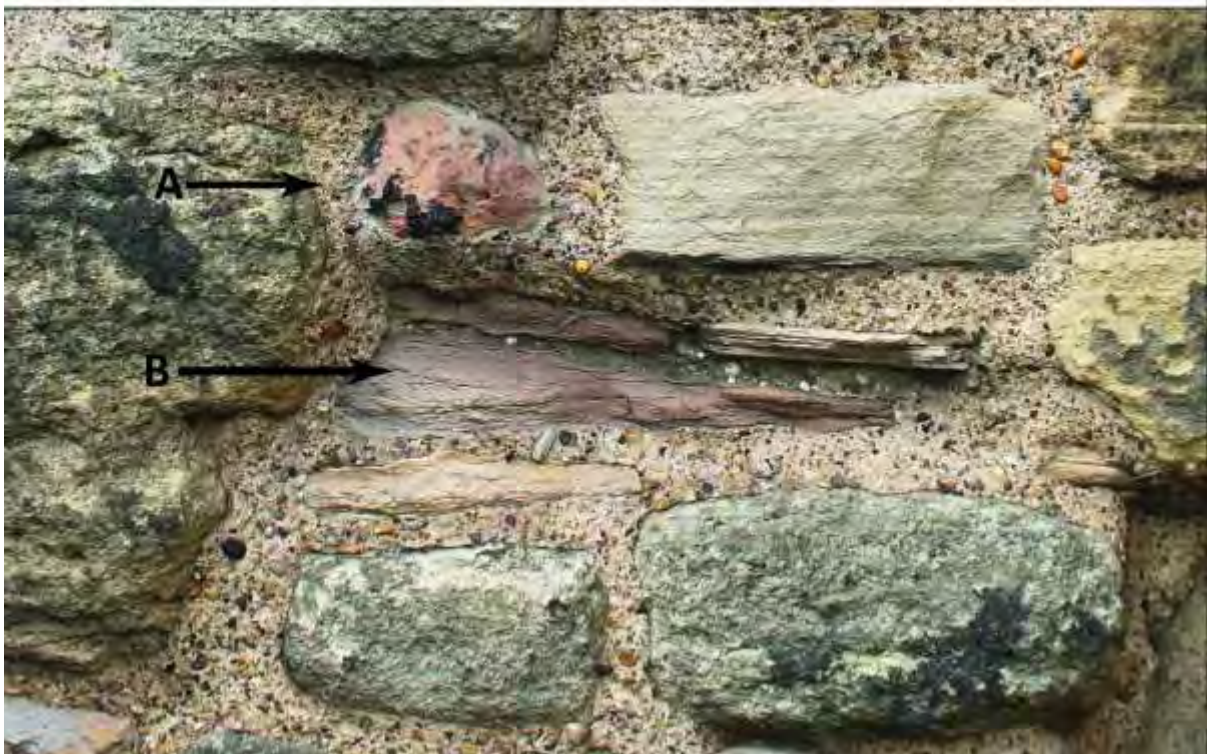
Figure 25: Top: Naturally reddened sandstone from Dean Quarry and Roman stone cut from pale oolitic dolomite. St. Peter's, Wearmouth. Bottom: Reddened sandstone fragment in the Anglo-Saxon fabric of St. Paul's, Jarrow(B) , located in the south-east part of the external east wall. Sitting below a fragment of reddened Roman brick (A).

Illustrations: Photomicrographs (Figs 44a, b, c); Arbeia (Fig 42); St Peter's, Wearmouth (Fig 25a); St Paul's, Jarrow (Fig 25b).

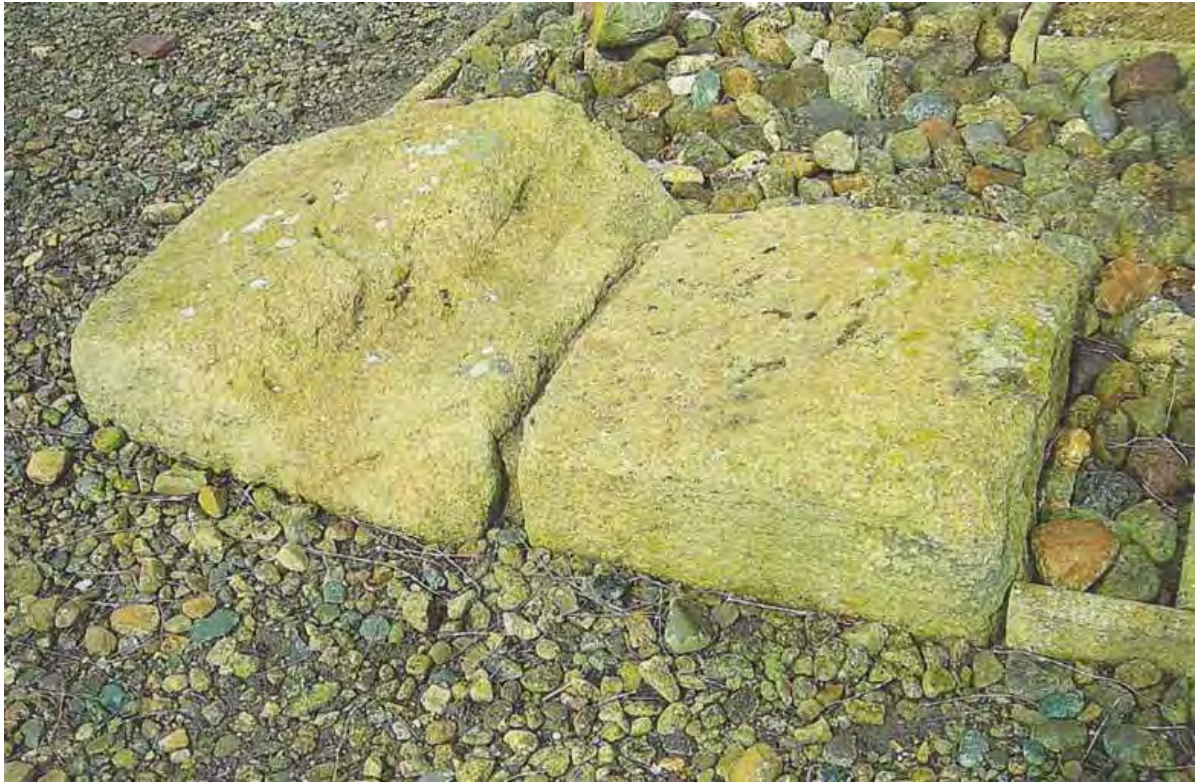
Figure 26a: Base blocks of Millstone Grit used for the East Gate at Segedunum. Bottom:

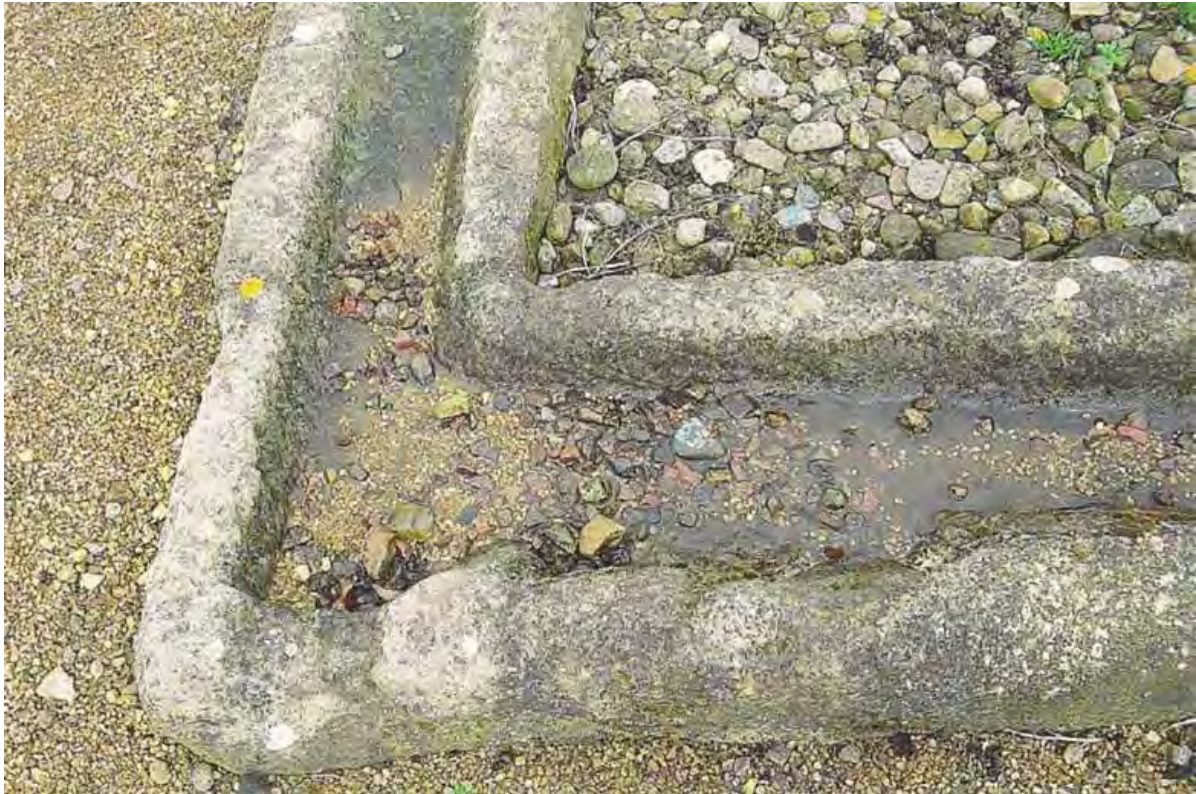
Figure 27a: Drainage culverts at Segedunum, executed from 70 fathom Post Sandstone.

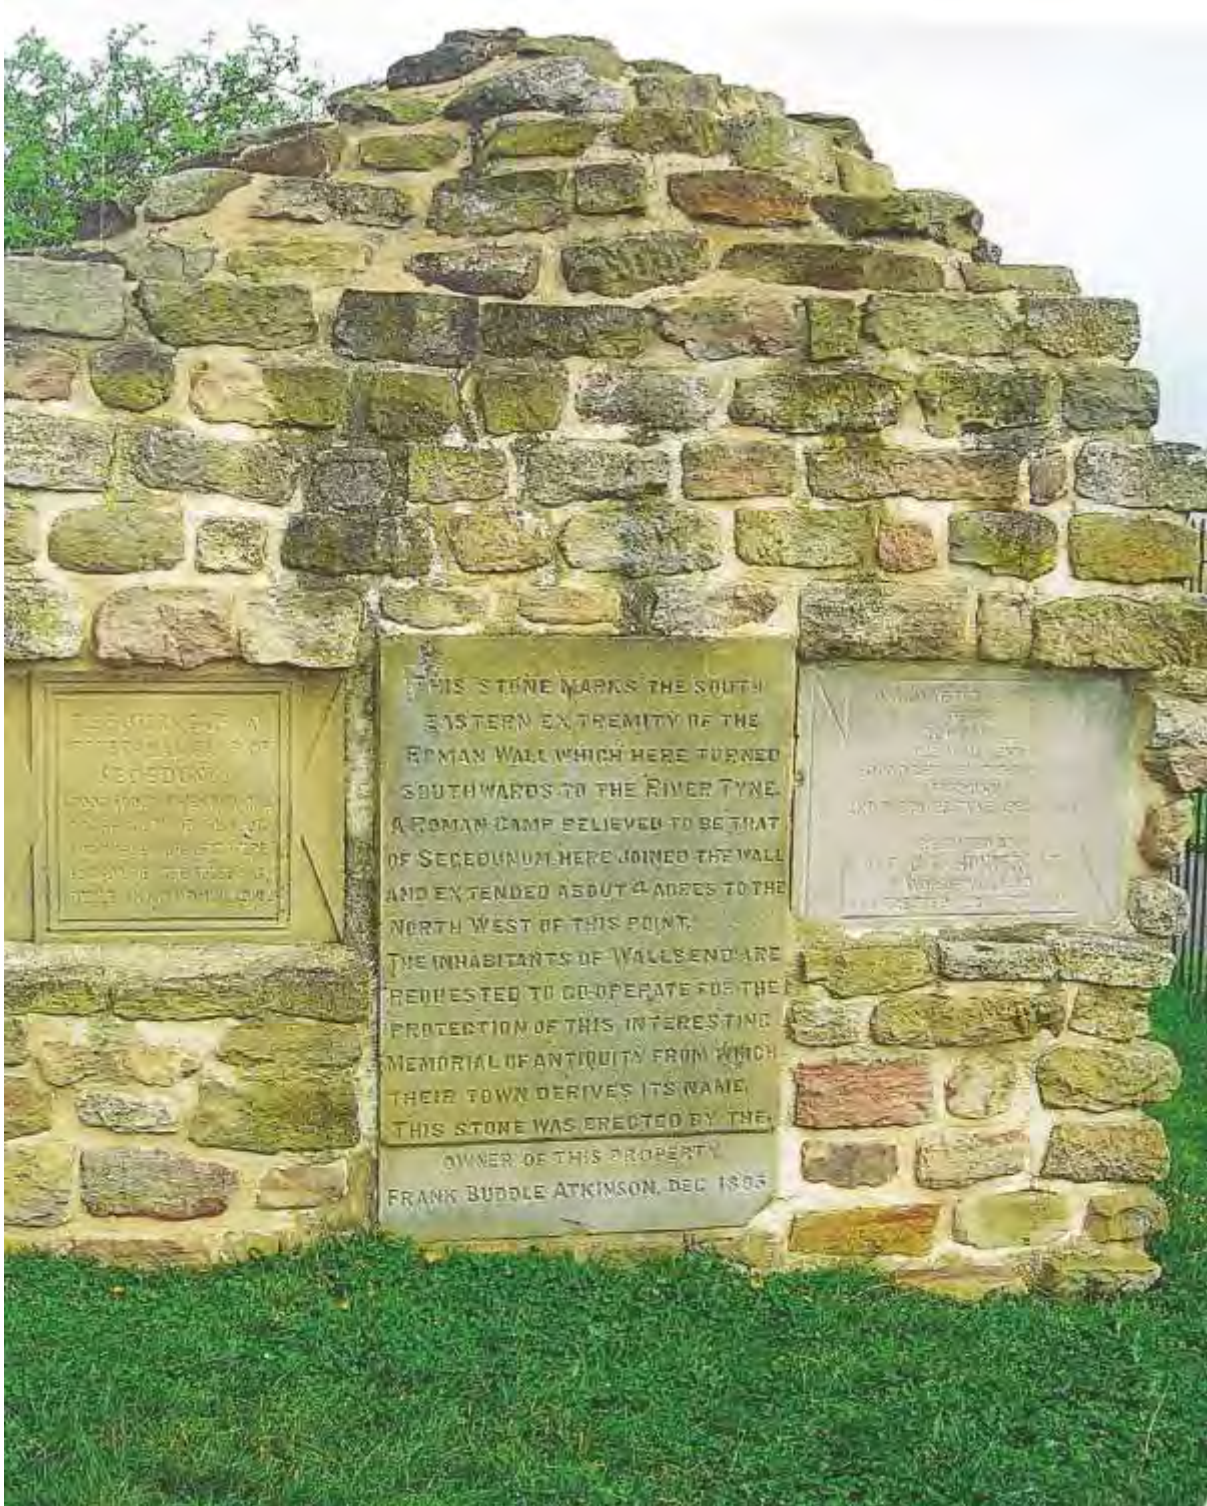
Figure 28: Recently constructed walling supporting 19th and 20th century commemoration slabs. Constructed from Roman squared rubble, probably from Arbeia.

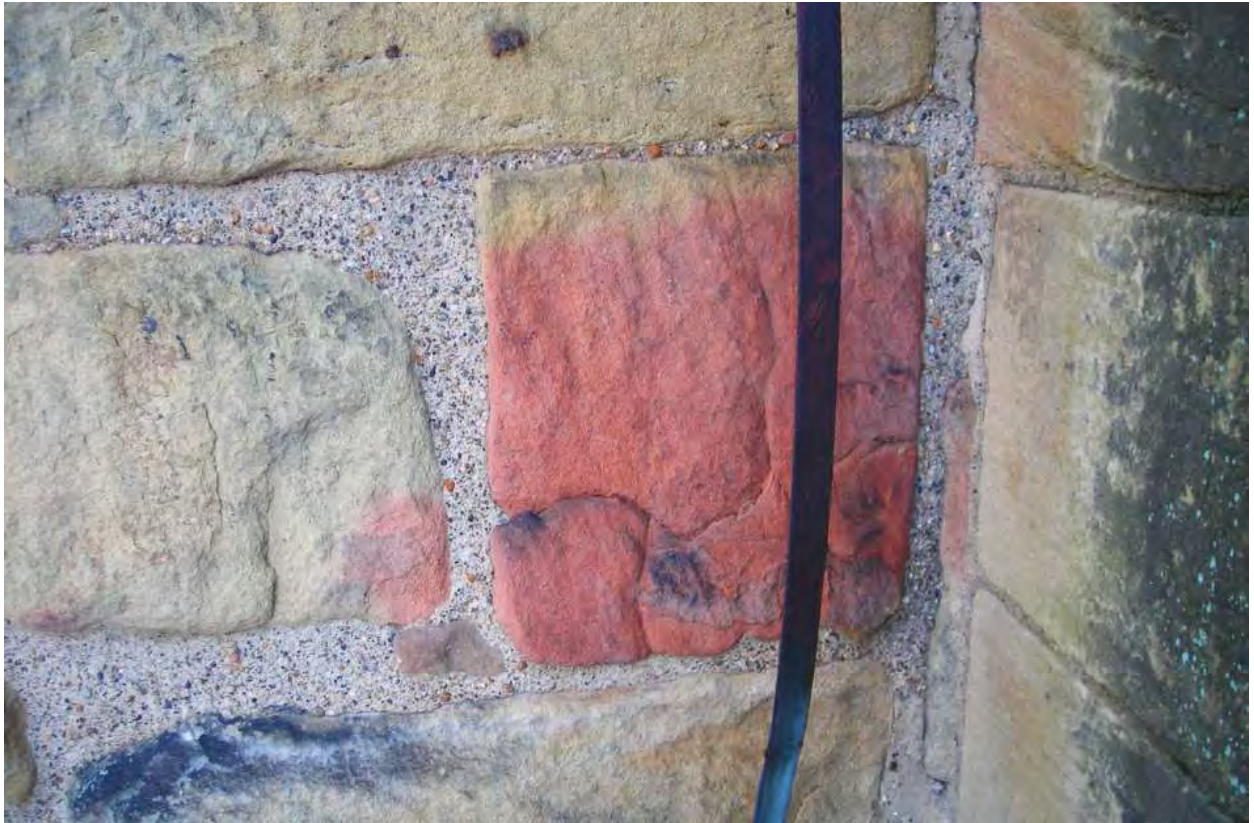
Figure 29: Roman cut stone blocks reused at Jarrow. Exterior, north-west corner of Eastern Church. Stones appear to have been burned prior to their use in the pre-Conquest structure.

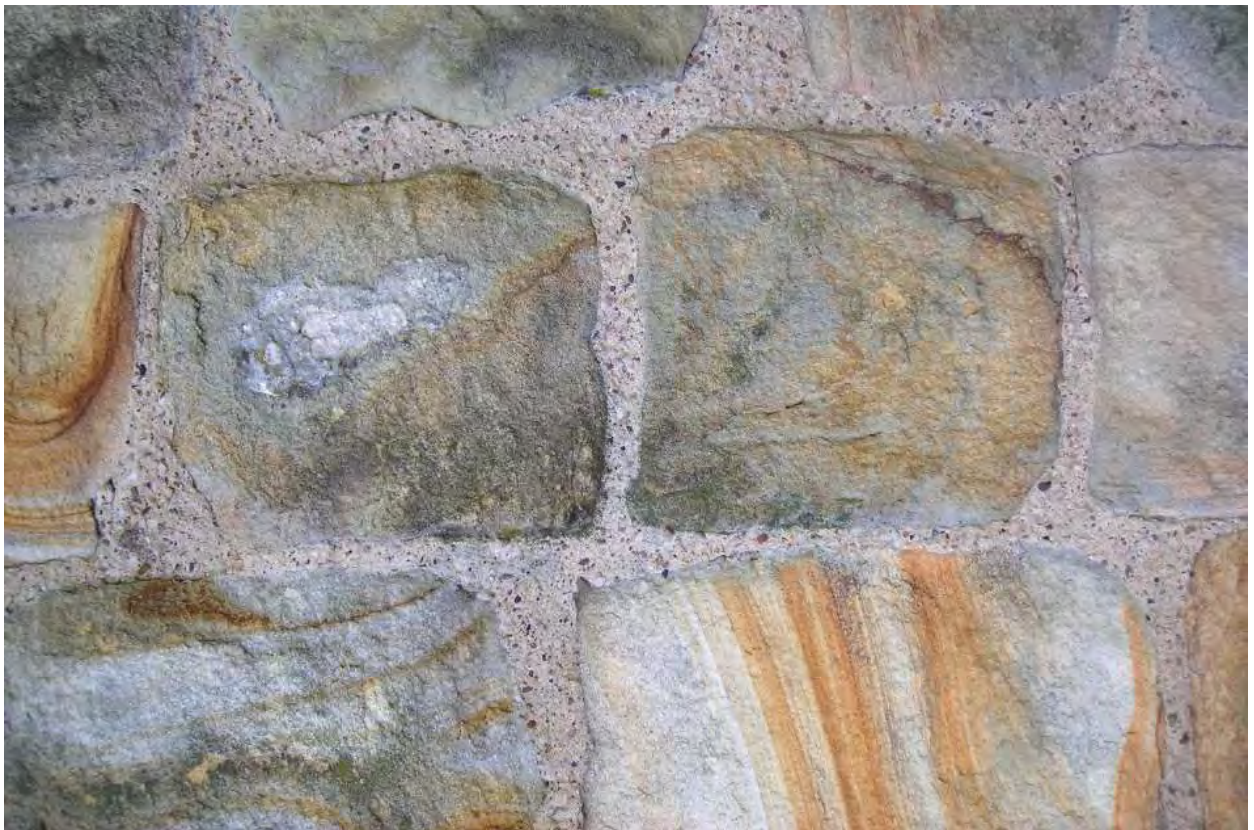
Figure 30: Ferruginous liesegang marks in Wrekenton Sandstone. Located in the upper section of the tower of St. Peter's,

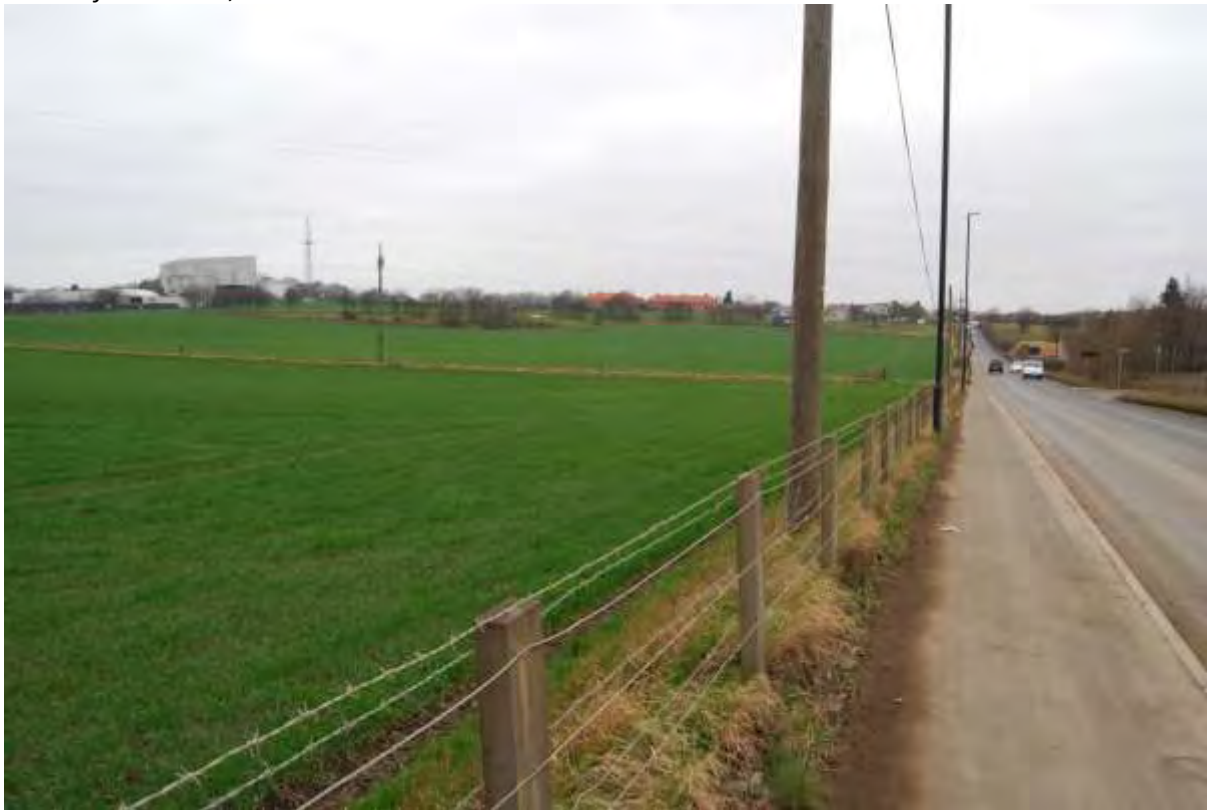
Figure 31a: Site of the earliest known quarry, probably the original Roman quarry site, at Wrekenton, once located on the restored fields shown to the left of the road. View looking north to Wrekenton and the Roman Road, Wrekendyke (809) on the sky-line (NZ 280 691).

Source Location: This stone came from the older quarries at Wrekenton (Fig 31a; NZ 280590) near the Wrekendyke Roman road (Fig 31b). A very pale brown (10YR 8/4) sandstone from the deeper most recent quarries (also now backfilled) in the same formation at Springwell (NZ 282593) have been used for replacement quoins at St Peter's, Wearmouth.

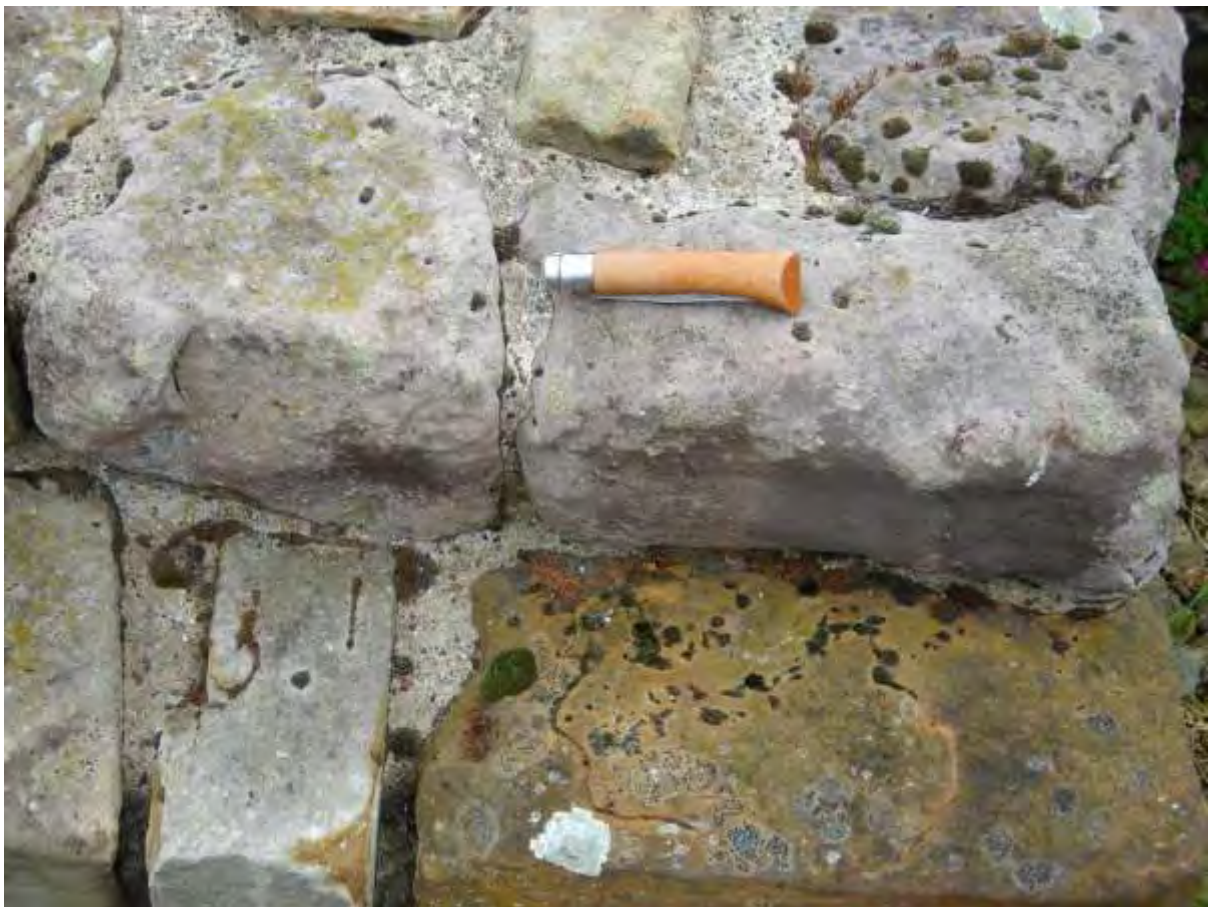
Figure 32: Arbeia: squared rubble walling in Dean Sandstone (Type B). Note the pick shade to the body colour of the stone.

Recorded: Used extensively in the construction of the supply fort at Arbeia (Fig 32), stone reused on site during later periods of remodelling and rebuilding. Not seen at all in the verifiable, Roman-constructed walls as Segedunum. Very small quantities found in the standing Anglo-Saxon fabric at St Paul's Jarrow (Fig 25b) in the form of built rubble and more consistently as cut ashlar in the porch interior (Fig 1). Found sporadically throughout the Anglo-Saxon and Anglo-Norman walls at St Peter's, Wearmouth.
