Petrological Analysis of the Anglo-Saxon and Anglo-Norman Stonework of St Peter's, Wearmouth and St Paul's, Jarrow

John Senior
With Sarah Semple, Alex Turner and Sam Turner
McCord Centre Report 2014.2

April 2014

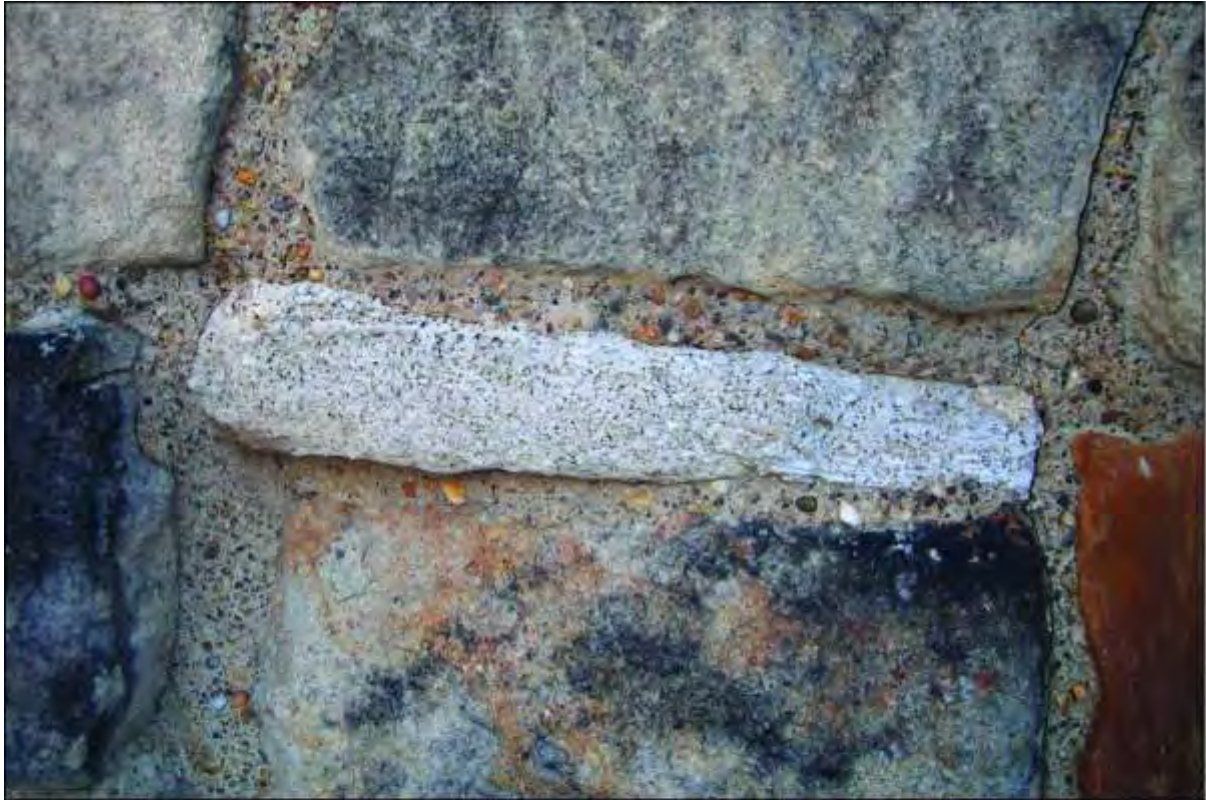
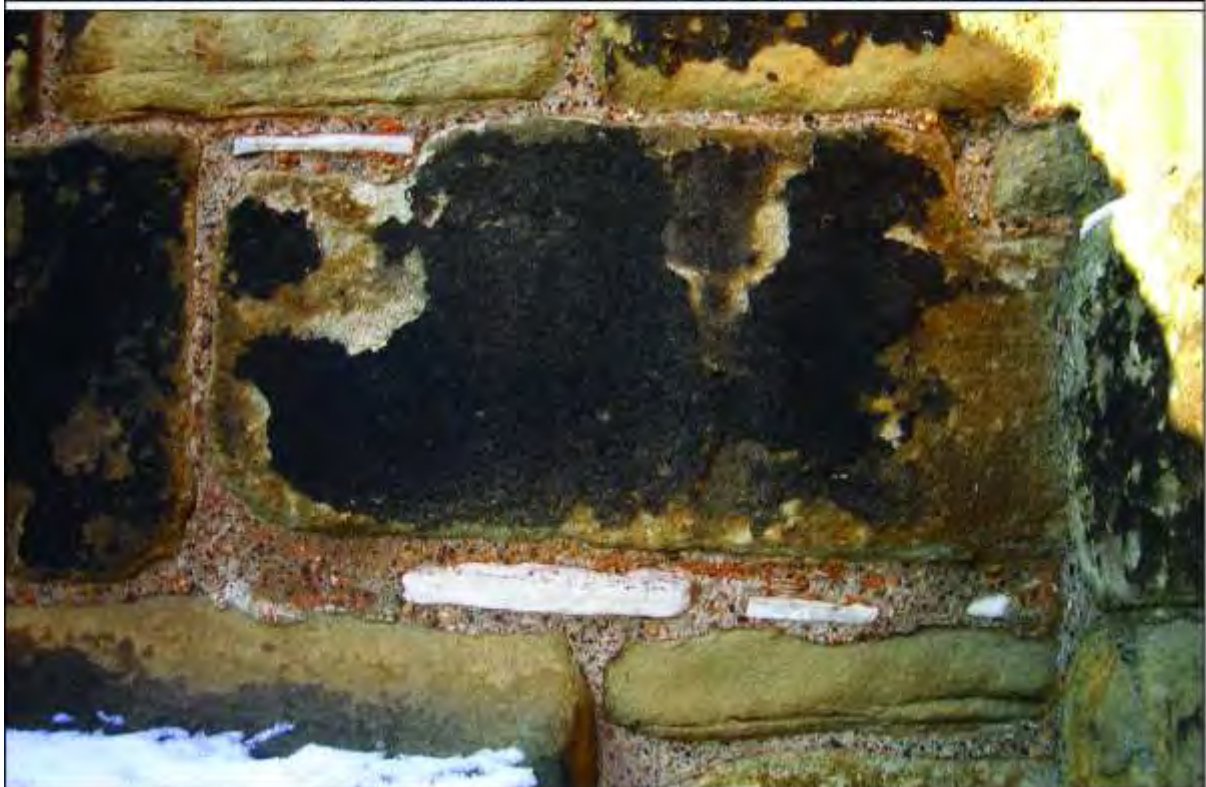
Figure 33: Use of Magnesian Limestone in an Anglo-Saxon context at St. Paul's, Jarrow: a) as packing in the frame of the North Doorway; b) As packing at the east end of the church (south-east corner).²⁶

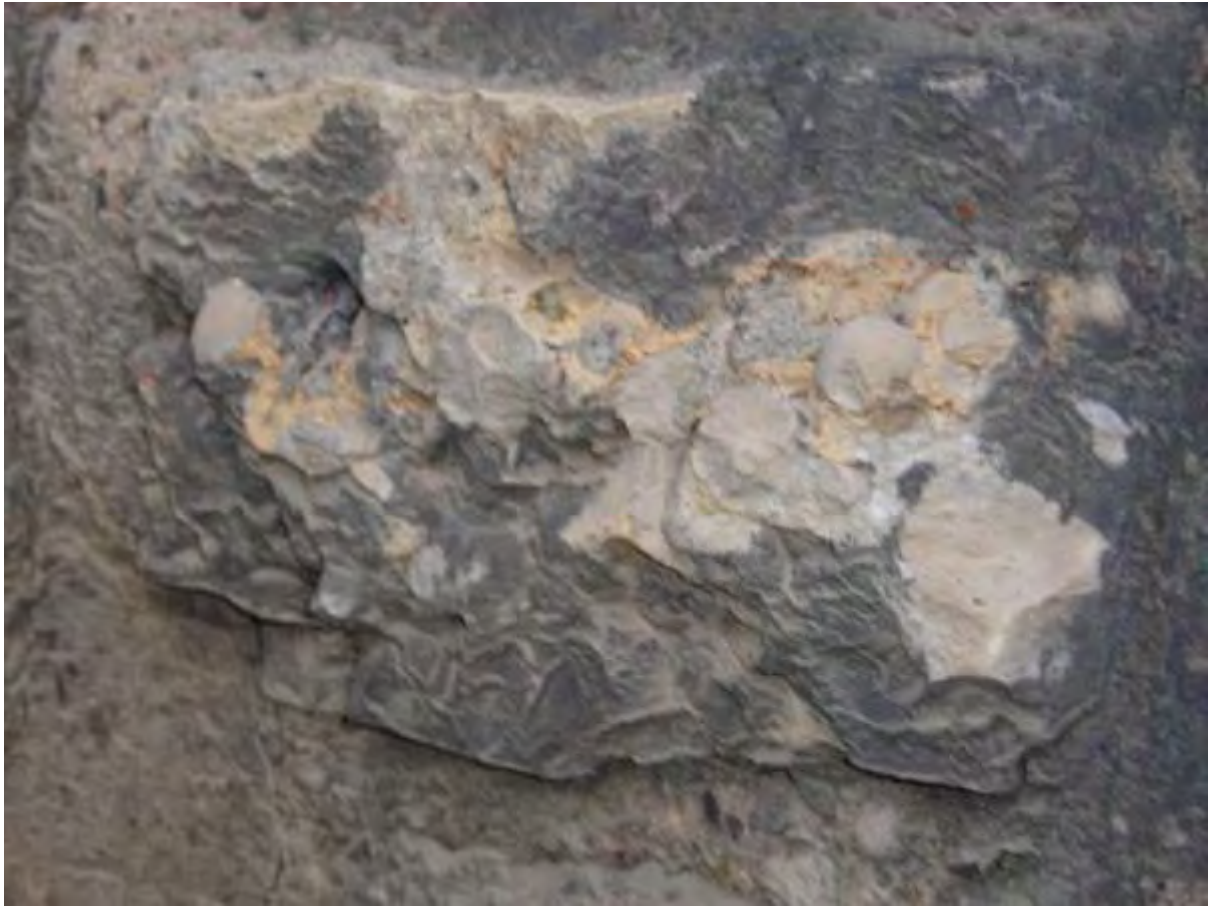
Figure 34a: Types of Permian Roker Dolomite (Lower Magnesian Limestone) present in the standing fabric at St. Peter's, Wearmouth: a) Cannonball Limestone

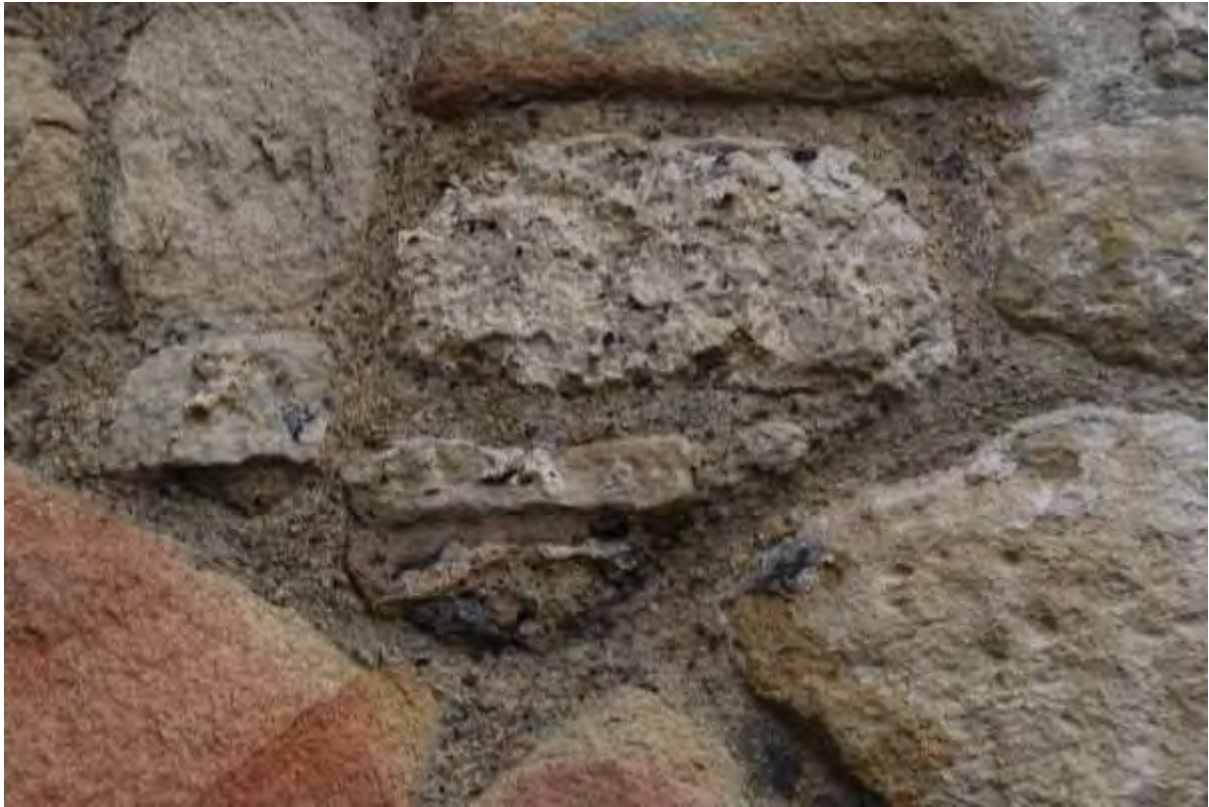
Figure 34b: Types of Permian Roker Dolomite (Lower Magnesian Limestone) present in the standing fabric at St. Peter's , Wearmouth: b) Spherulite Limestone

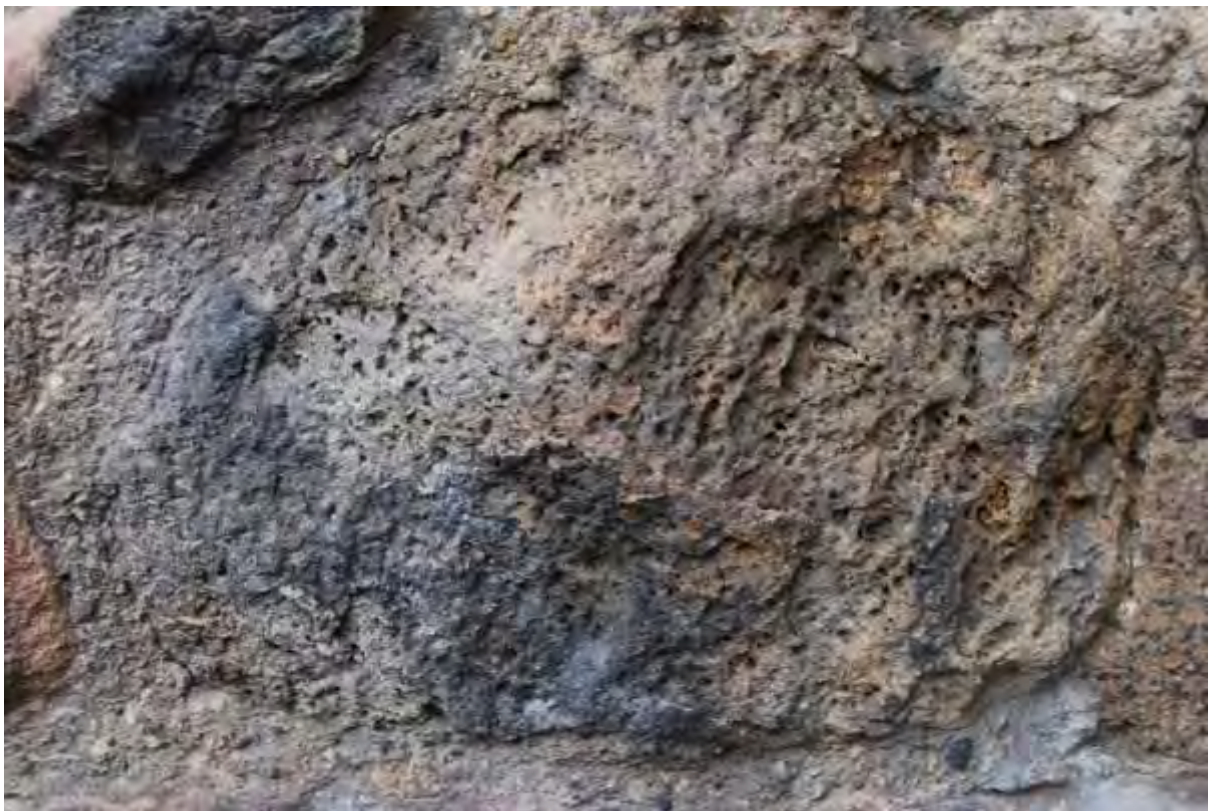
Figure 35a: Sample of cellular structures in Concretionary Limestone, Upper Permian present in the standing fabric at St. Peter's, Wearmouth.

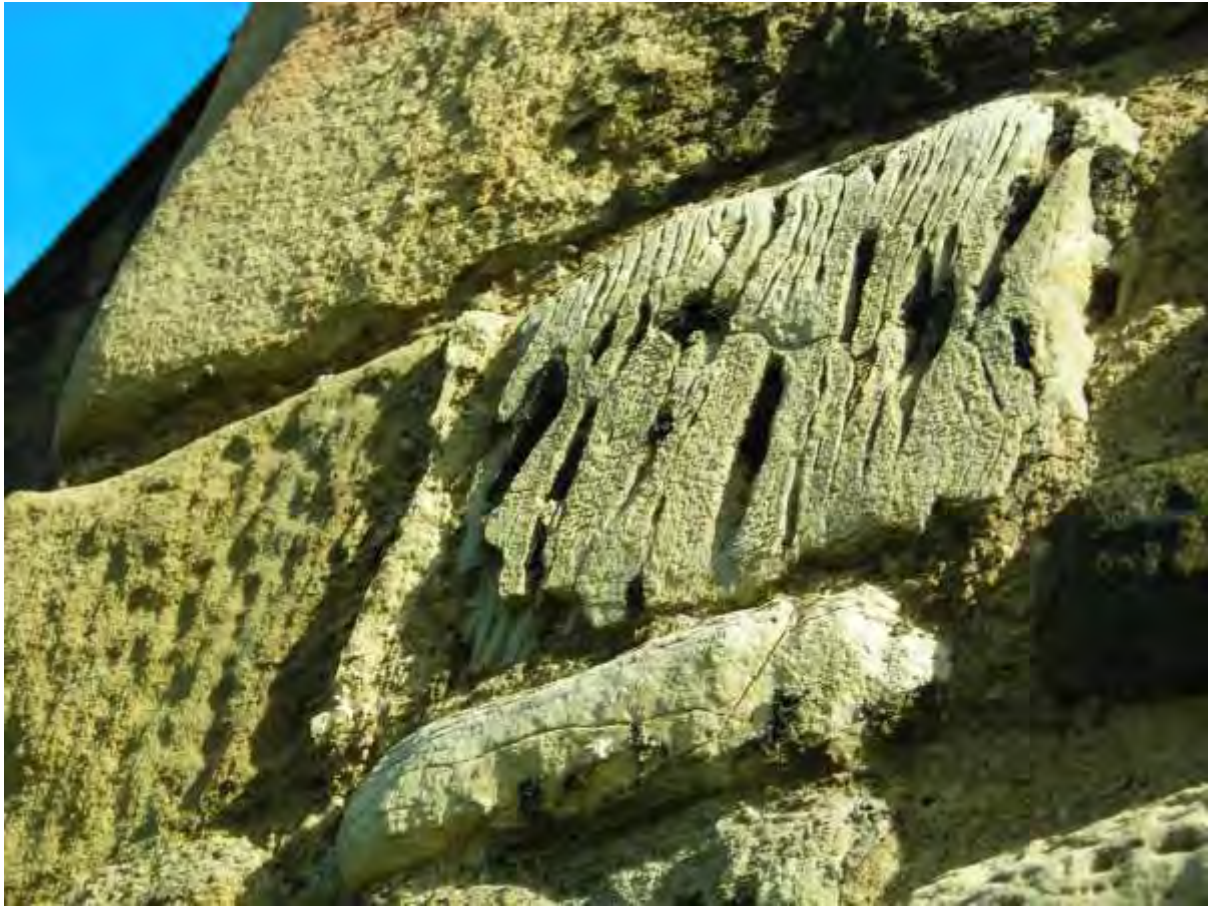
Figure 35b: Sample of cellular structures in Concretionary Limestone, Upper Permian present in the standing fabric at St. Peter's, Wearmouth.

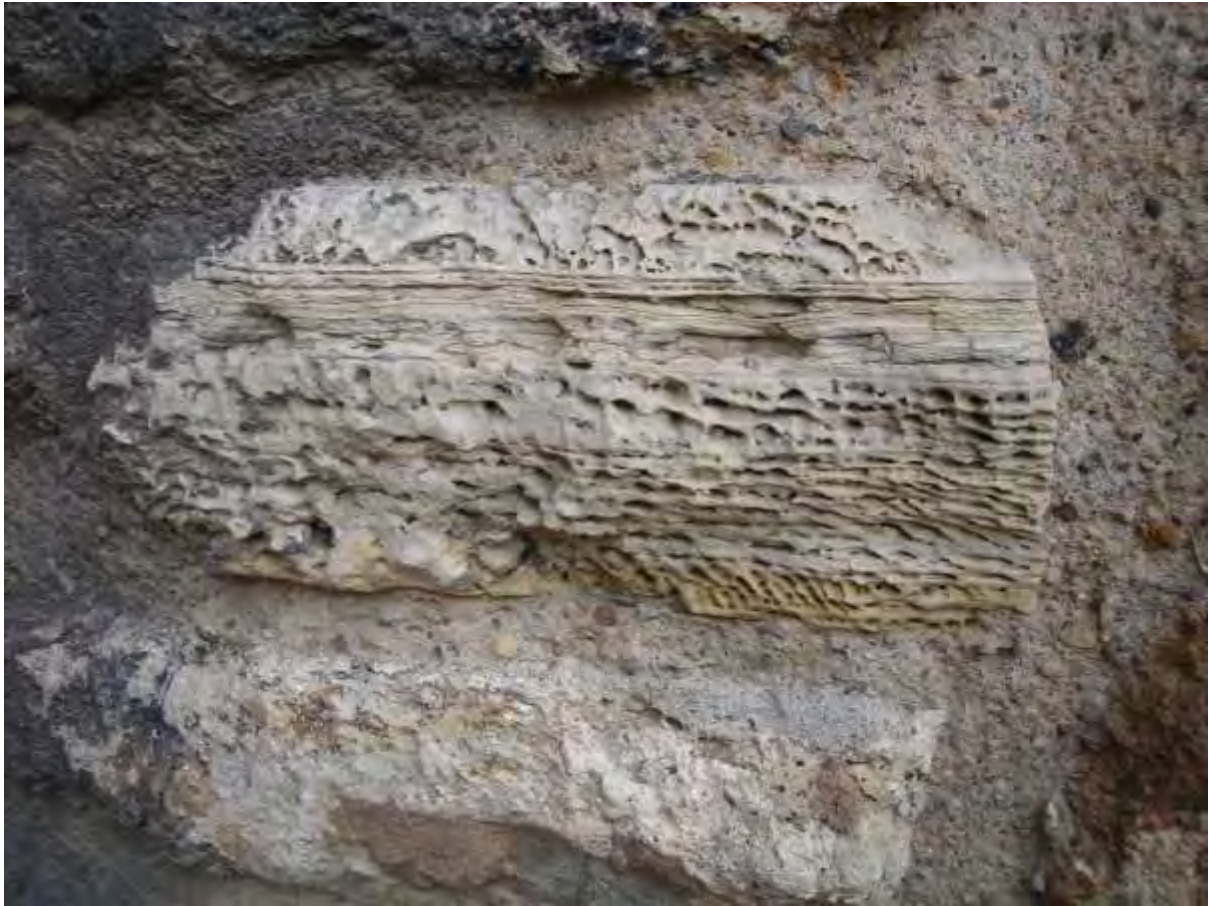
Figure 35c: Sample of cellular structures in Concretionary Limestone, Upper Permian present in the standing fabric at St. Peter's, Wearmouth.

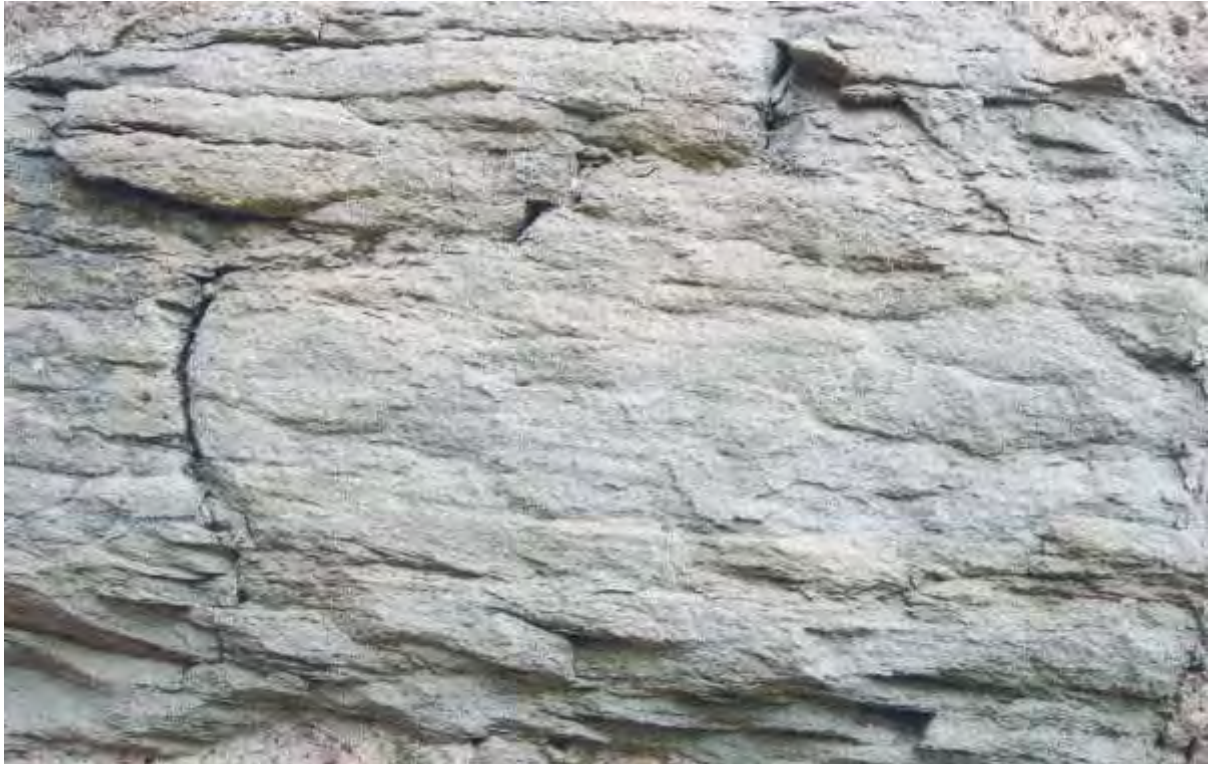
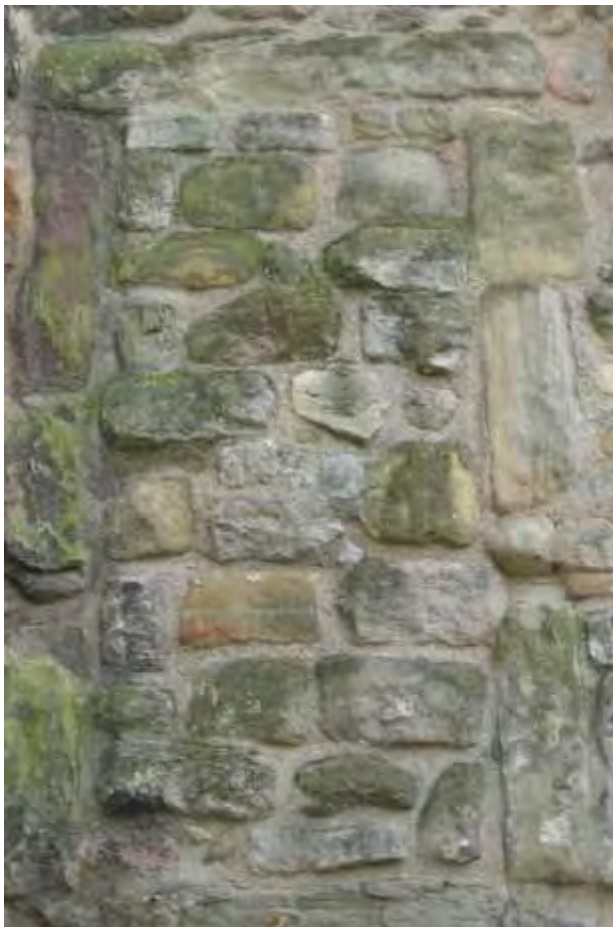
Figure 36: Soft Upper Carboniferous sandstone from the North Hylton area of Sunderland, used in the standing fabric of St. Peter's Church, Wearmouth; above) detail of the poor quality of this ashlar stone; below) weathered ashlar used in the in-filled doorway on north-facing exterior wall of the porch at St. Peter's.

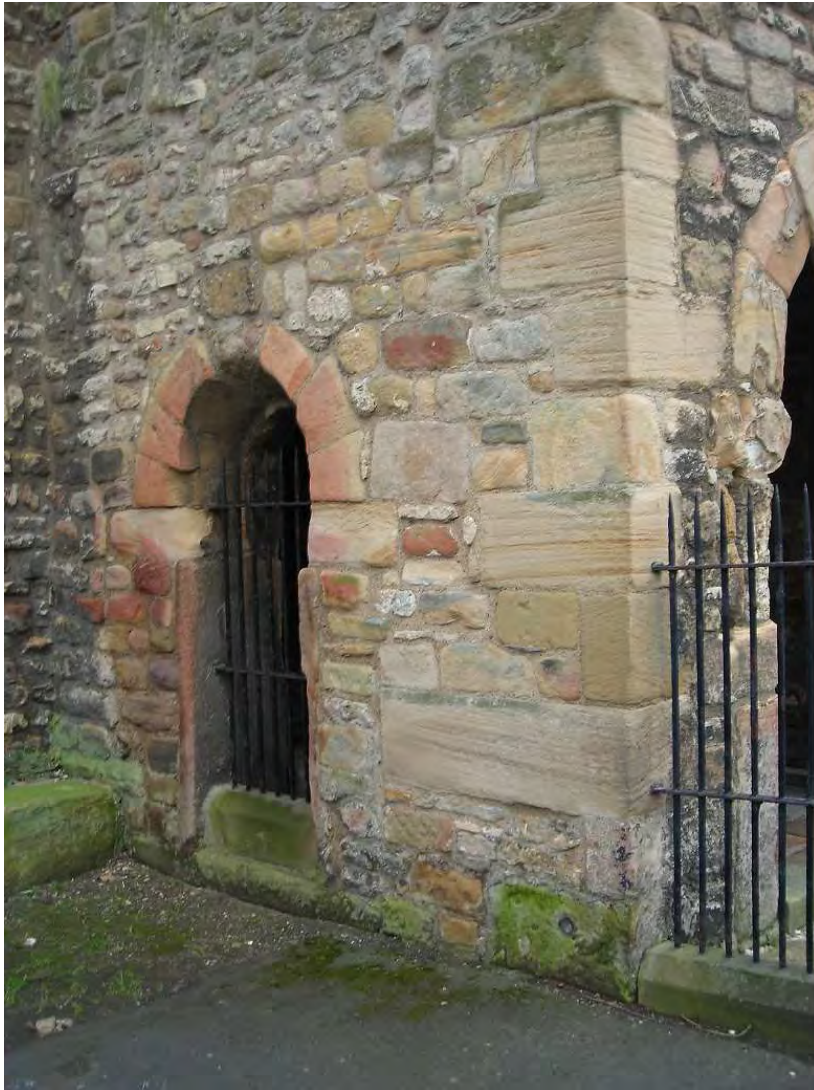
Figure 39: The north doorway of the porch at St. Peter's Church, Wearmouth, showing considerable fire reddening on the stone.

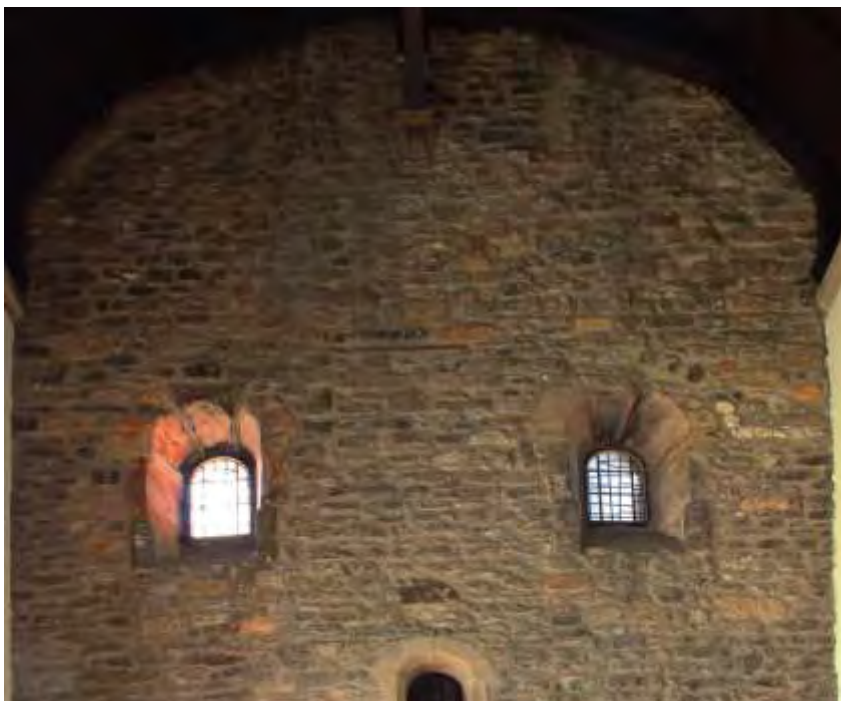
Figure 41a: interior stone work at the western end of the nave at St Peter's, Wearmouth, showing the burnt areas around the upper windows.

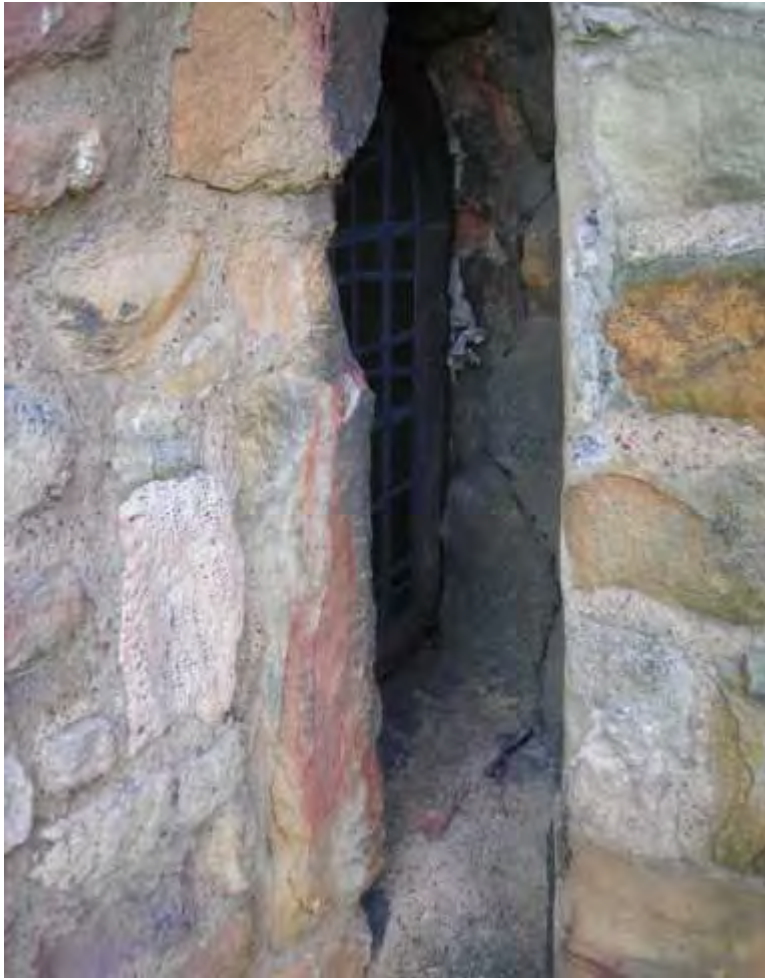
Figure 41b: Fire damage evident on the interior stonework in the western end of the nave at St. Peter's, Wearmouth.

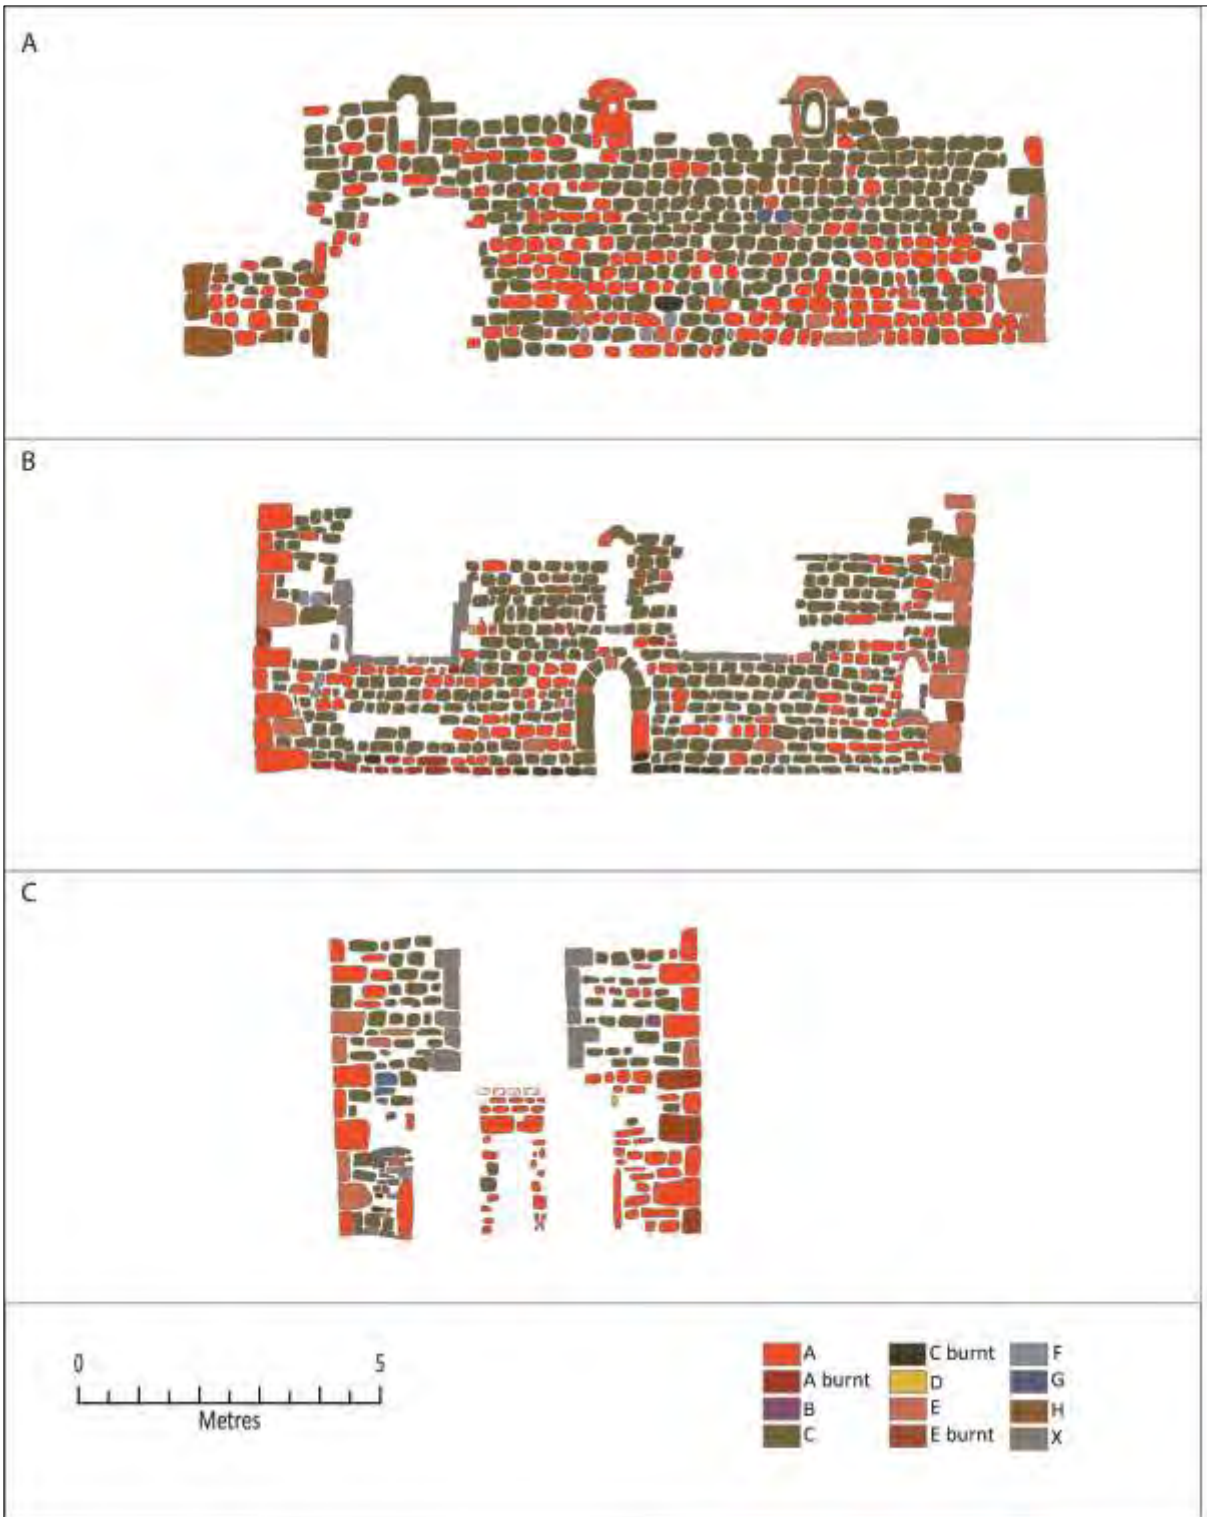
Figure 42 a-c: Stone surveys of the Anglo-Saxon outer walls of St Paul's, Jarrow.

Illustrations: Photomicrographs Fig 45a (Heddon-on-the-Wall), 45b (St Paul's, Jarrow), 45c (Roman Strongroom), Arbeia; Arbeia (Fig 22); Heddon-on-the-Wall (Fig 23); St Paul's, Jarrow (Fig 42a-c); St Peter's, Wearmouth (Fig 1).

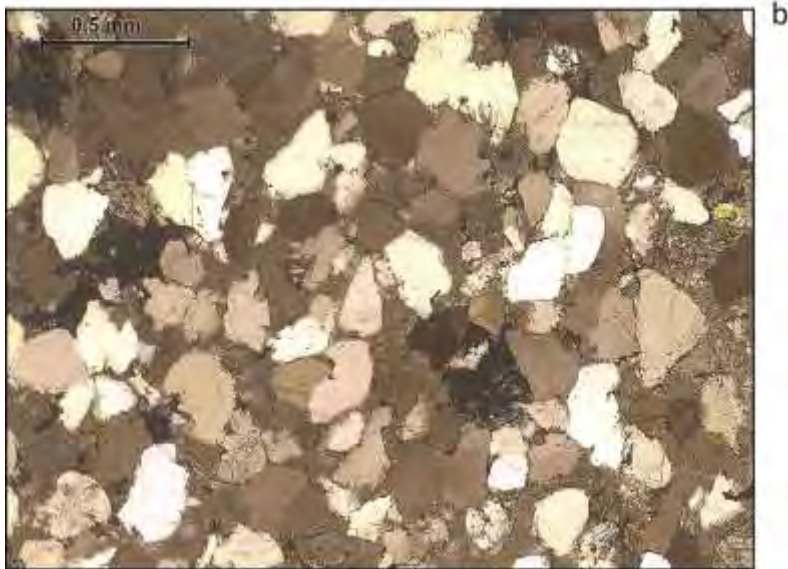
Figure 44 a-c: Photomicrographs Type B Dean Sandstone: a) Arbeia (ordinary light); b) St. Peter's, Wearmouth (ordinary light); Arbeia (polarised light). Note the patches of brown haematite coating to the grains (quartz and otherwise), which produces the pink body colour to the rock.

Illustrations: Photomicrographs (Figs 44a, b, c); Arbeia (Fig 42); St Peter's, Wearmouth (Fig 25a); St Paul's, Jarrow (Fig 25b).

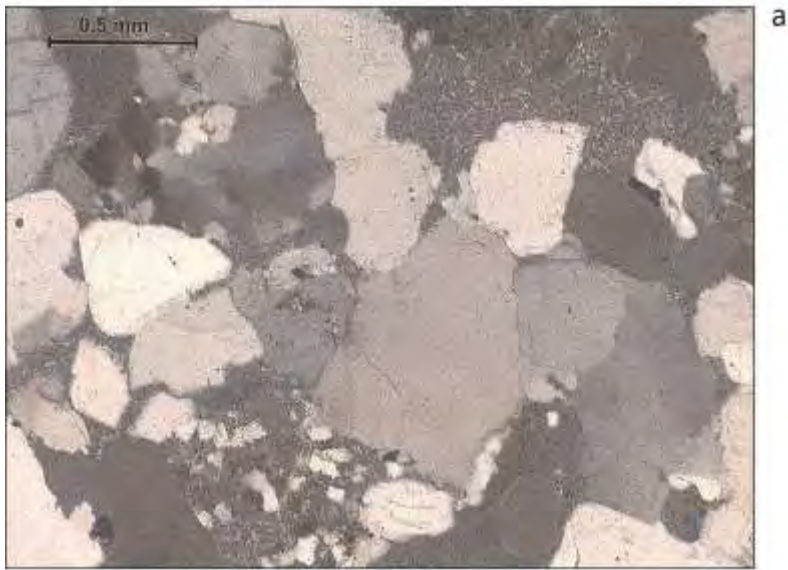
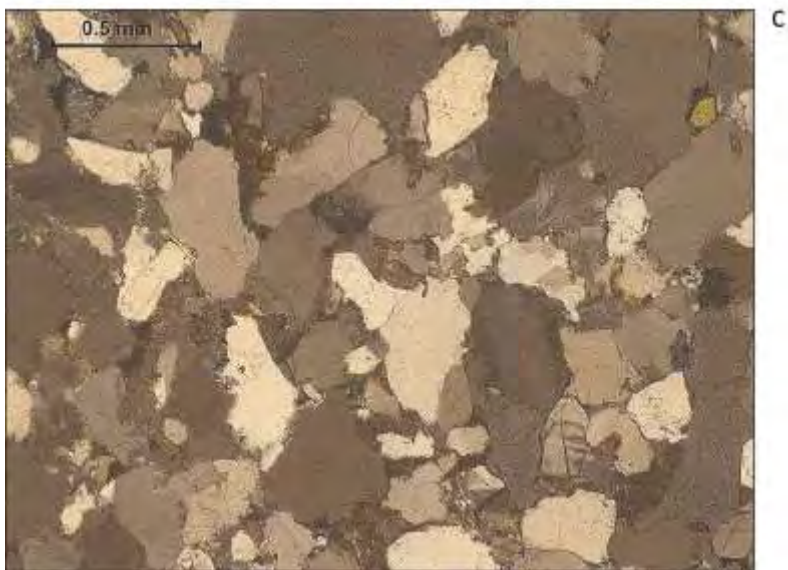
Figure 45 a-c: Photomicrographs 'Millstone Grit', Westphalian A, Upper Carboniferous: a) Heddon-on-the-Wall; b) St. Paul's, Jarrow; c) Strongroom, Arbeia.

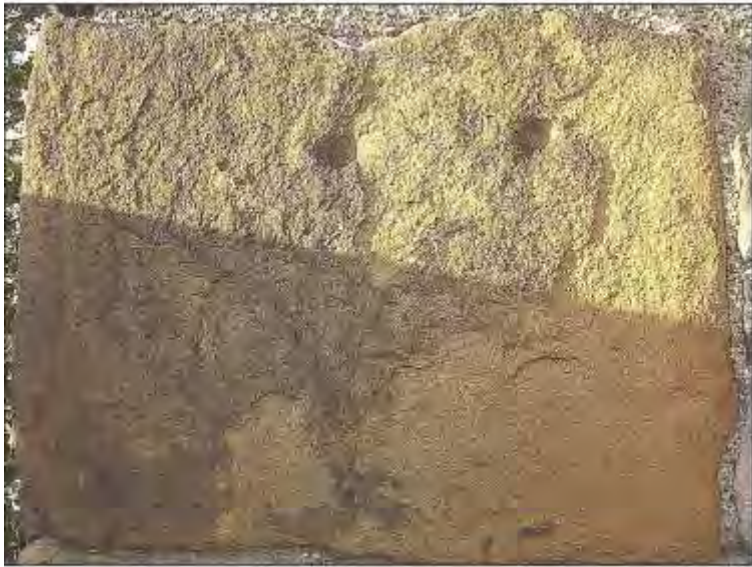
Figure 47 a-c: Roker Dolomite oolitic limestone: a) used as a building stone at St. Peter's, Wearmouth; b) photomicrograph showing the Oolite texture (ordinary light); c) photomicrograph showing the Oolite texture (polarised light).

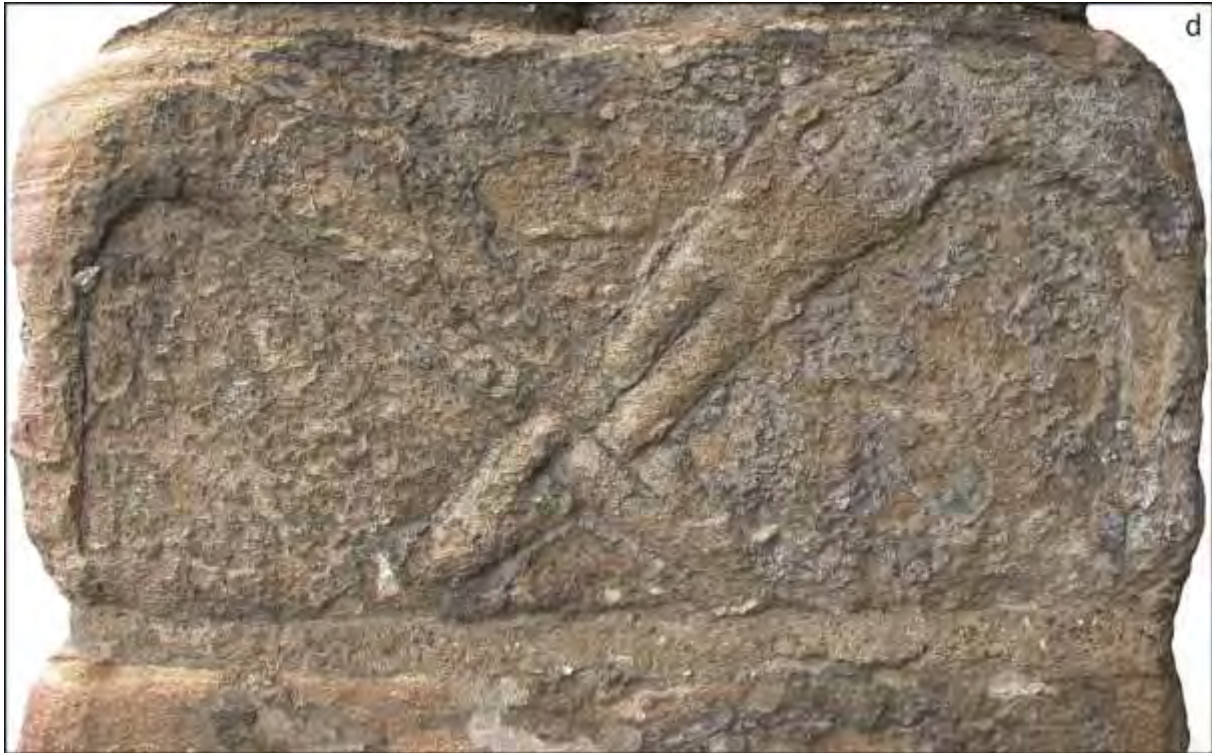
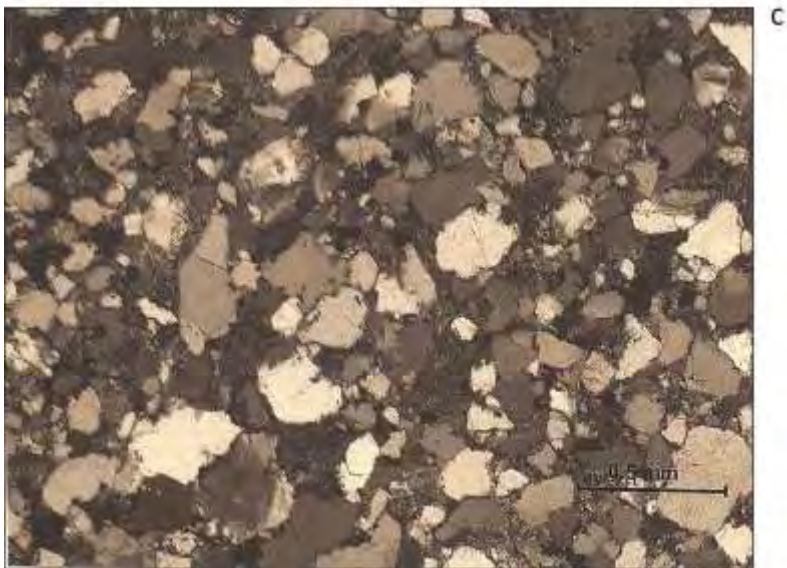
Figure 48 a-d: Type E Sandstone (Roman): a) reused as a quoin at the south-east corner of the east wall; b) photomicrograph of sample from Jarrow showing muscovite, mica flakes in typical sandstone matrix (polarised light); c) photomicrograph of sample from Jarrow showing extent of opaque limonite content (ordinary light); d) reused and sculpted stone used as part of the ornate entrance to the porch at St. Peter's, Wearmouth.
